# Compliance Review of Watercourse Impacts

Findings from a field assessment of selected watercourses within a 500m radius of the N2 Wild Coast Toll Highway Project (Greenfields Section)

Prepared by Steven Ellery (Pr.Sci.Nat – Ecology, MSc - Geography)

7 July 2026

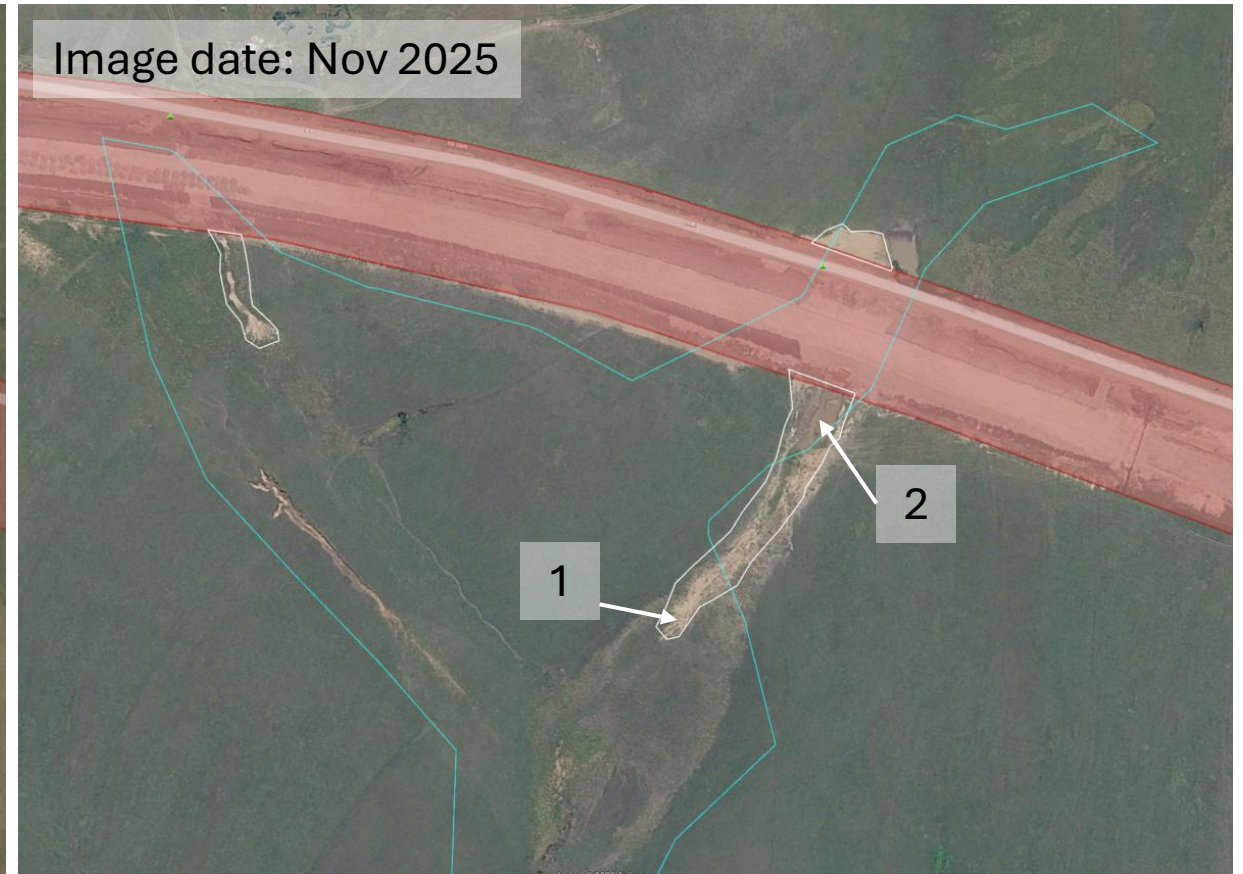
# CI-01: Sedimentation due to poor stormwater control – Example 1 Overview

- Non-compliance in terms of RoD clauses 6.1.1, 6.2.11.3, 6.2.11.4, 6.2.16 and EMPr clause 26 in Table 5.1, Aquatic EMPr: Multiple references

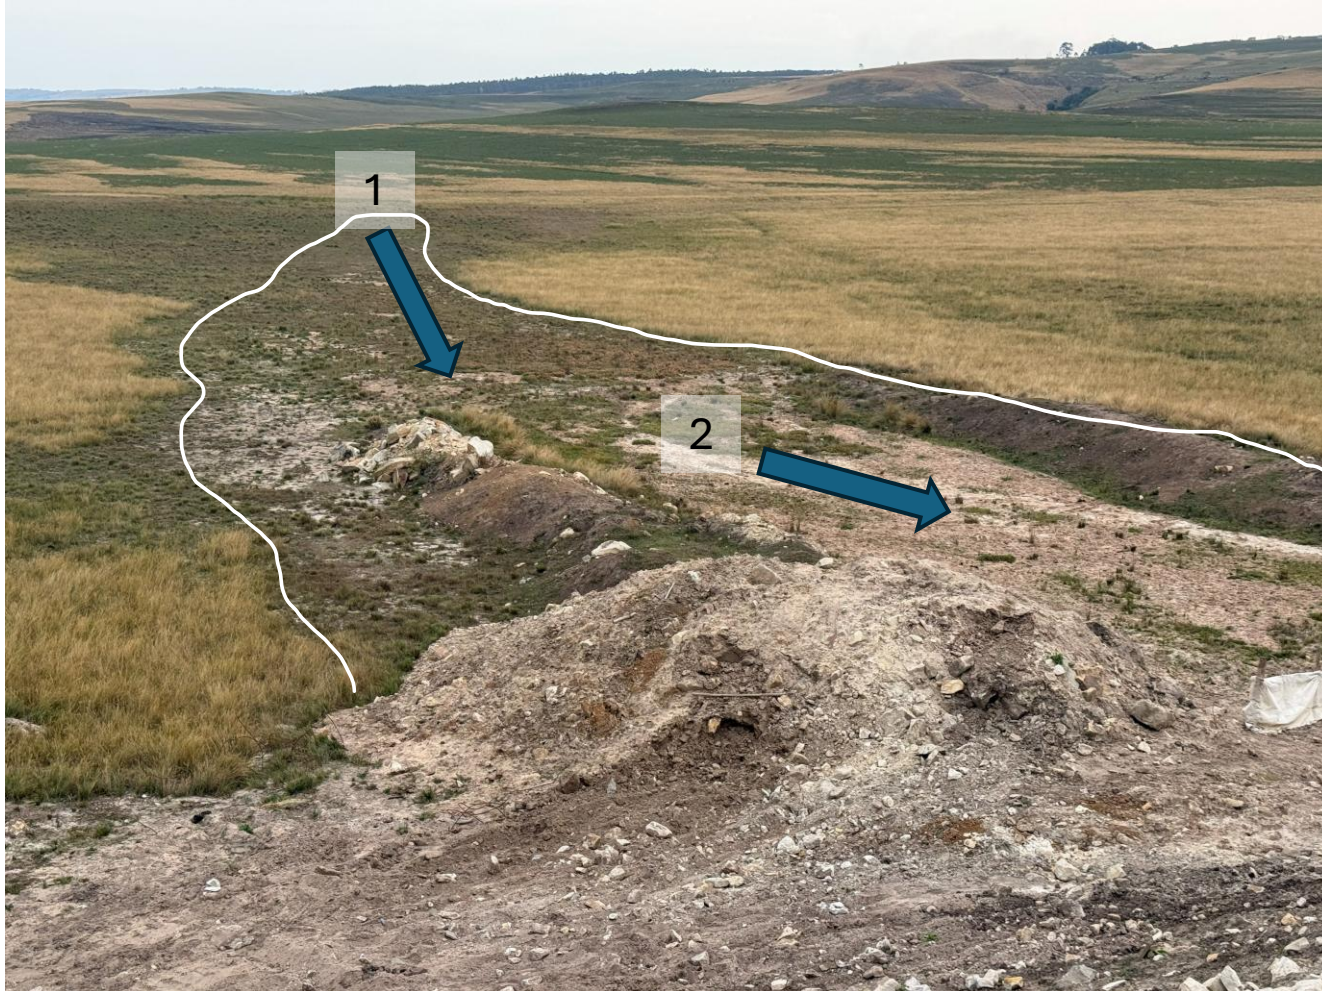
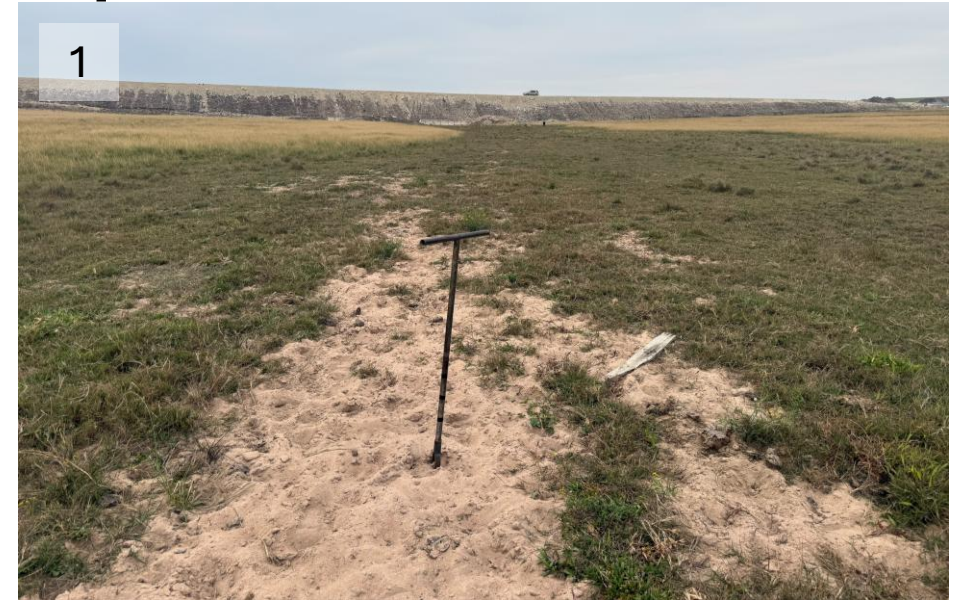
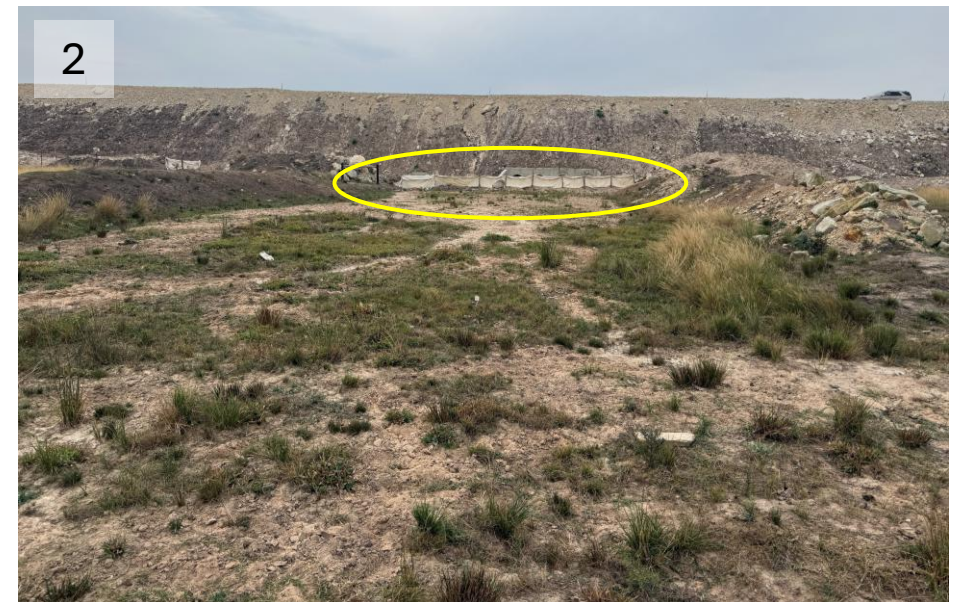
# CI-01: Sedimentation due to poor stormwater control – Example 1

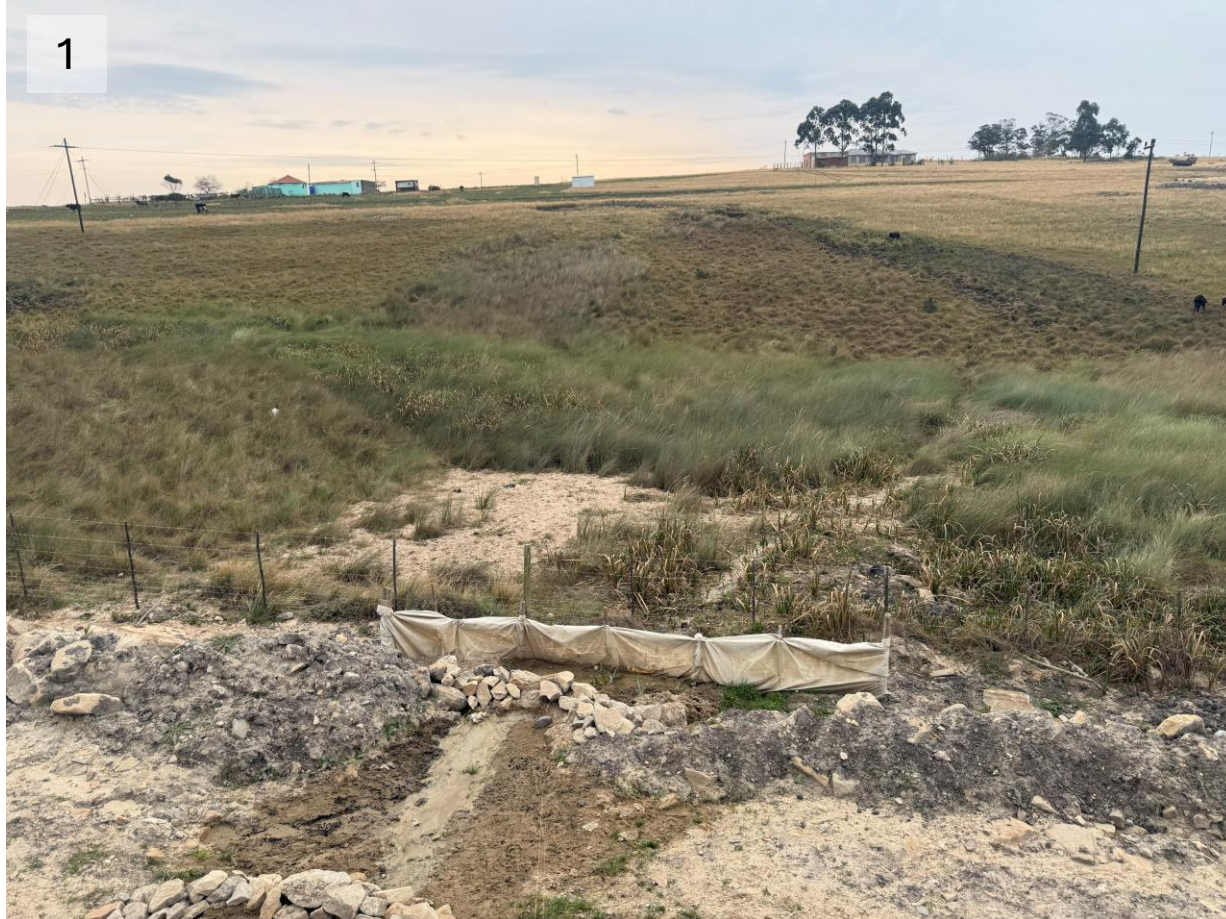
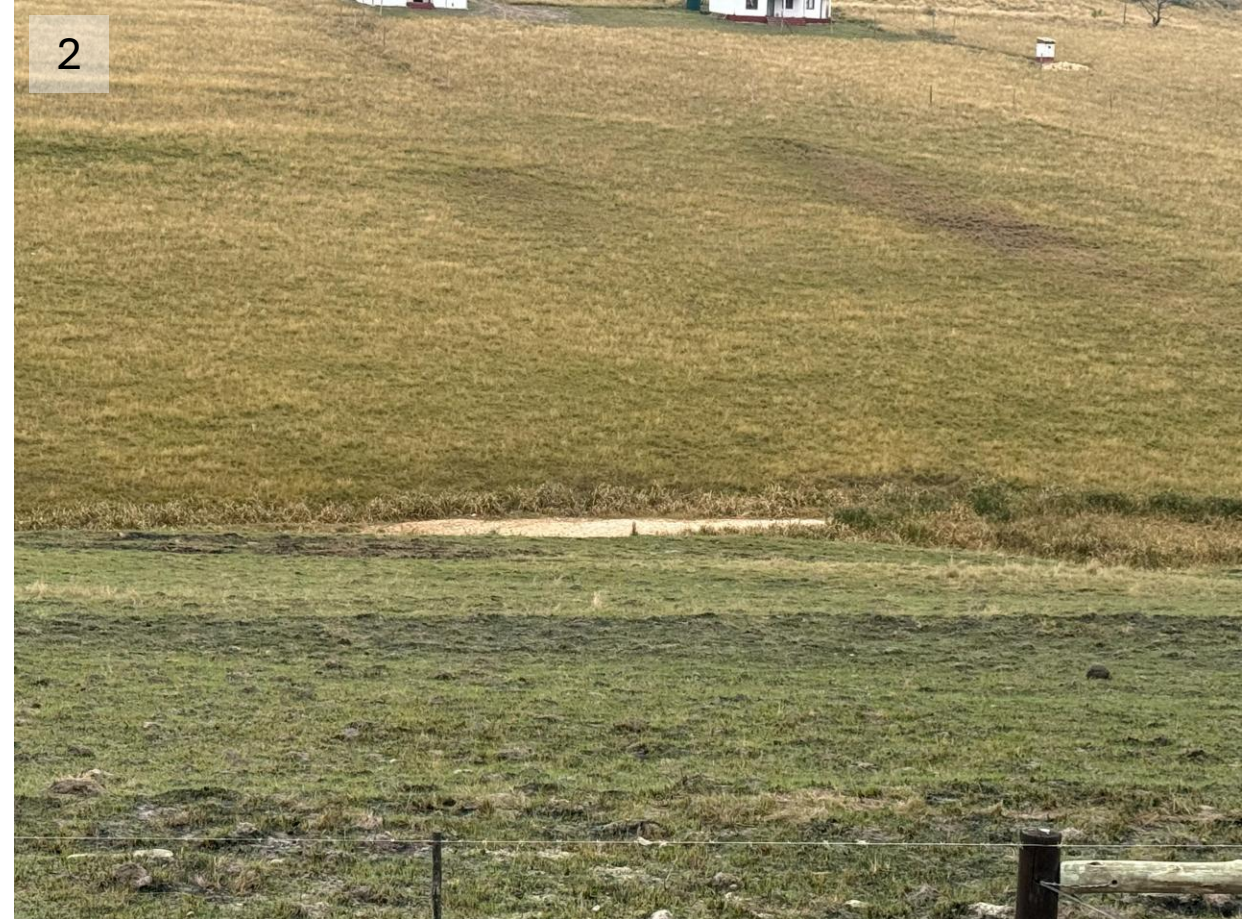
- Non-compliance in terms of RoD clauses 6.1.1, 6.2.11.4, 6.2.16 and EMPr clause 26 in Table 5.1, Aquatic EMPr: Multiple references

# CI-01: Sedimentation due to poor stormwater control – Example 2

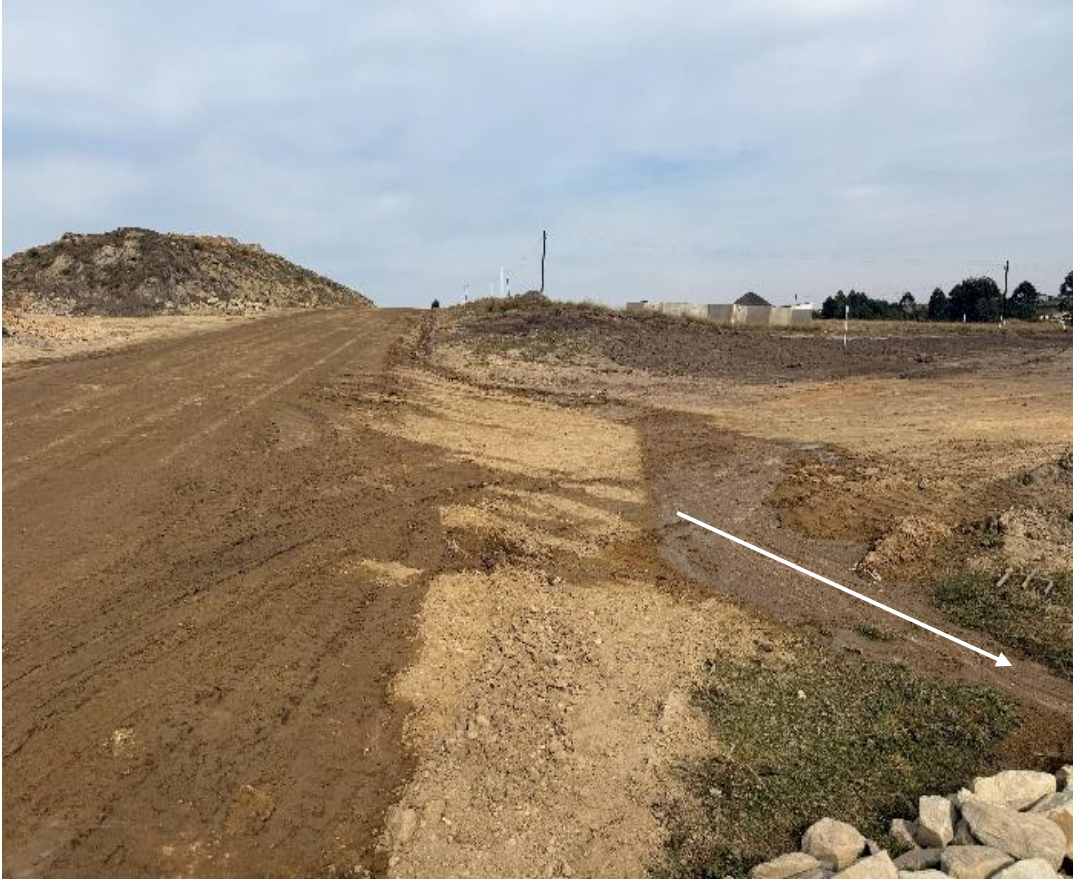
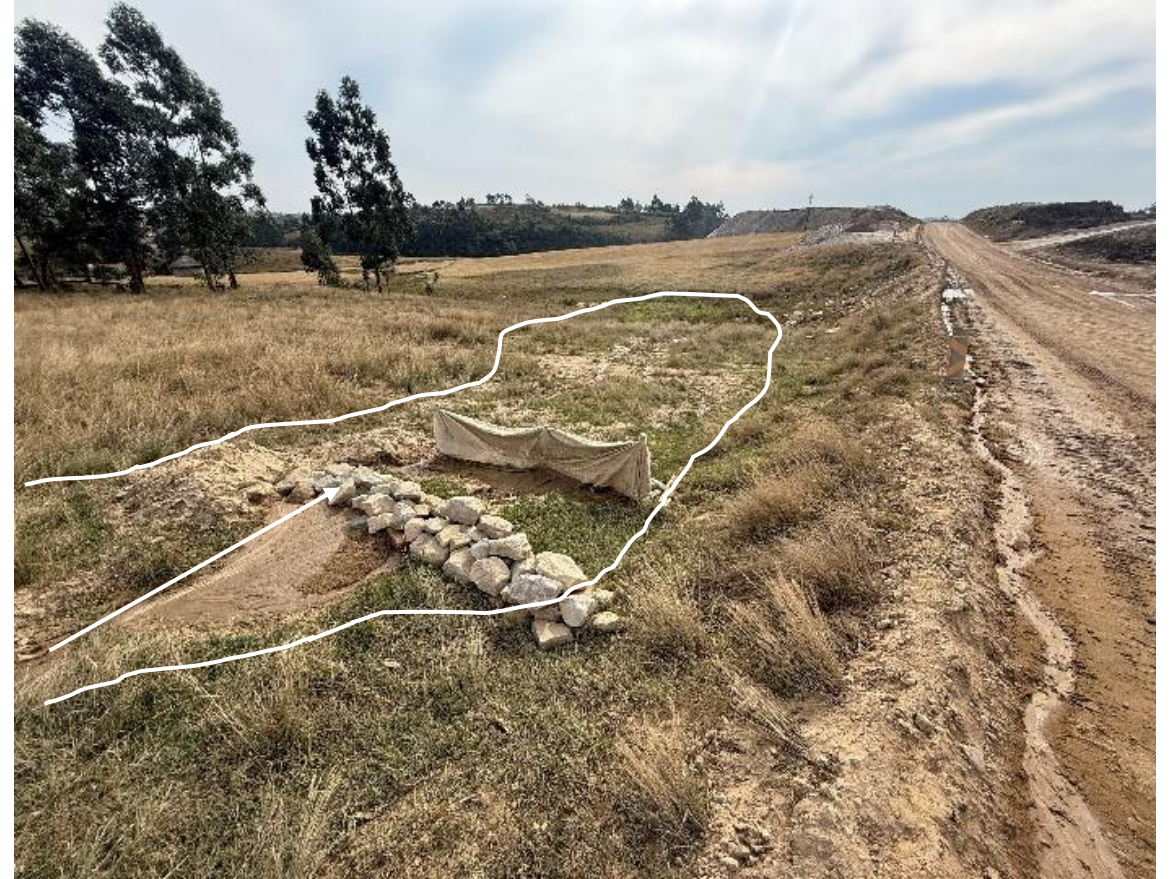
# CI-01: Sedimentation due to poor stormwater control – Additional Examples

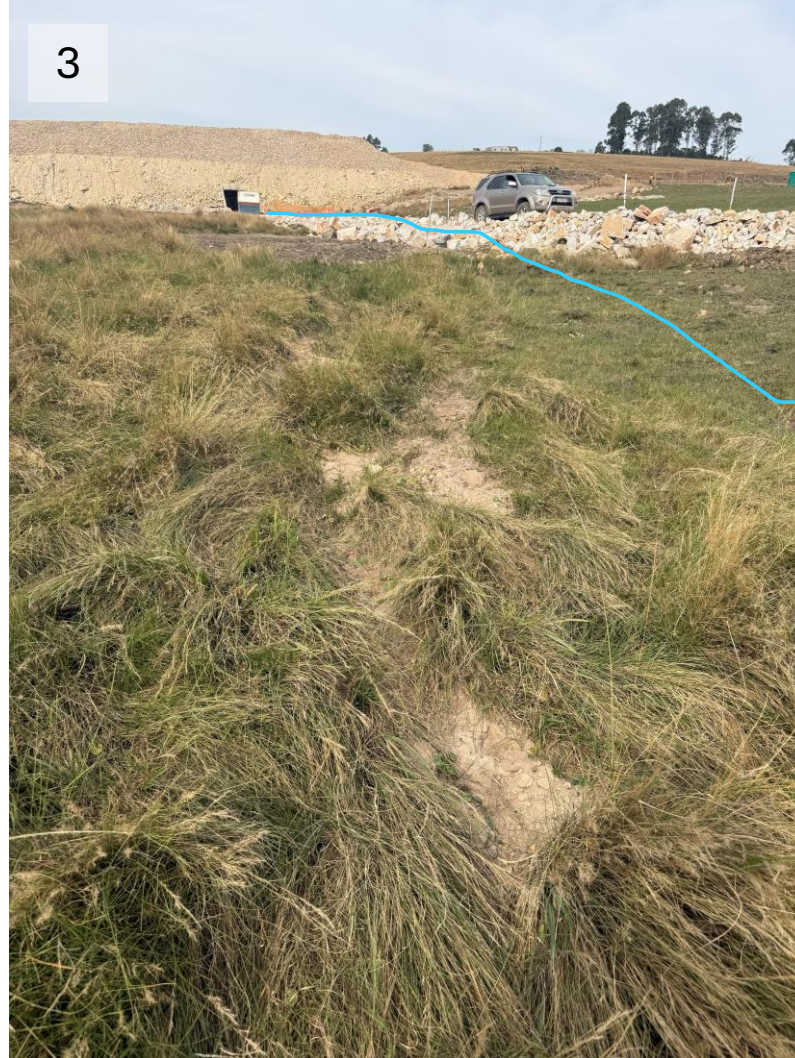
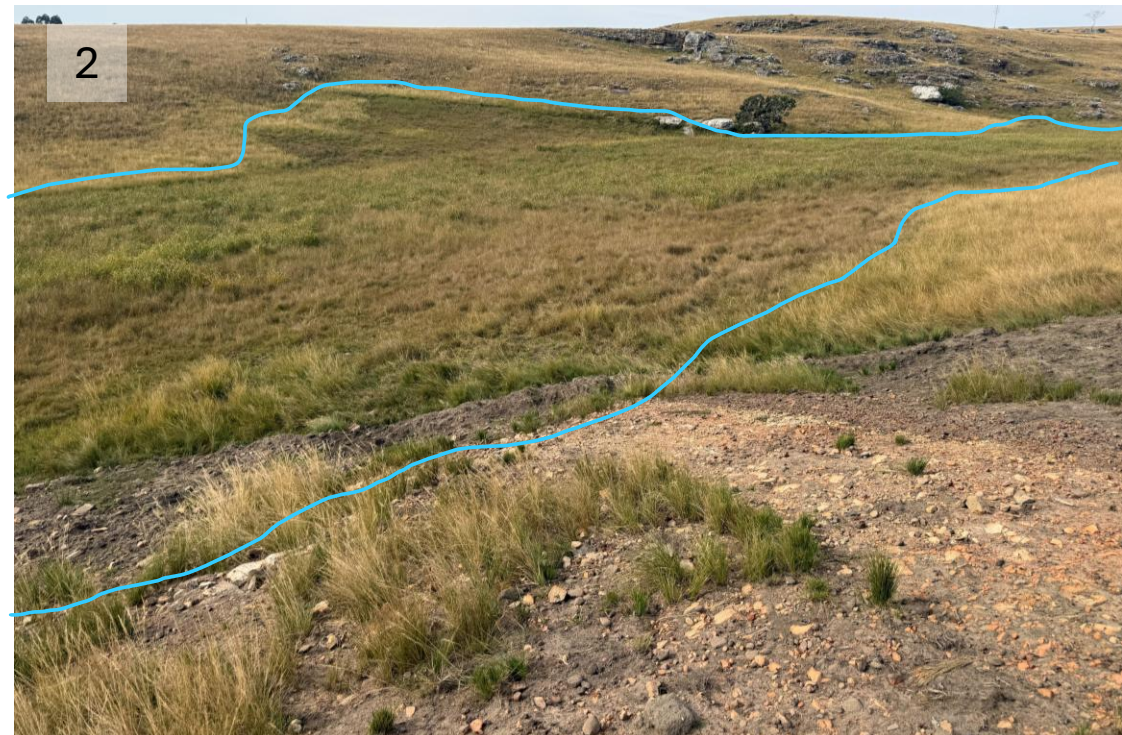
- Blue lines represent an approximation of the wetland boundaries
- No clear reason for the clearing undertaken in pictures 1 and 2. Access road has been build behind the location of picture 1

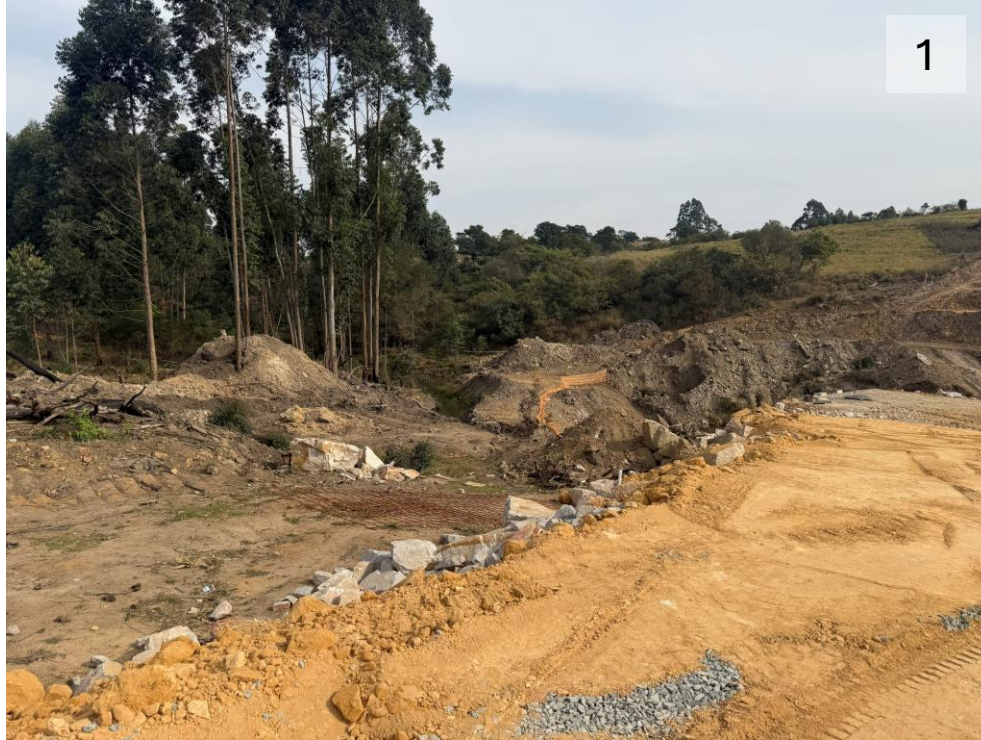
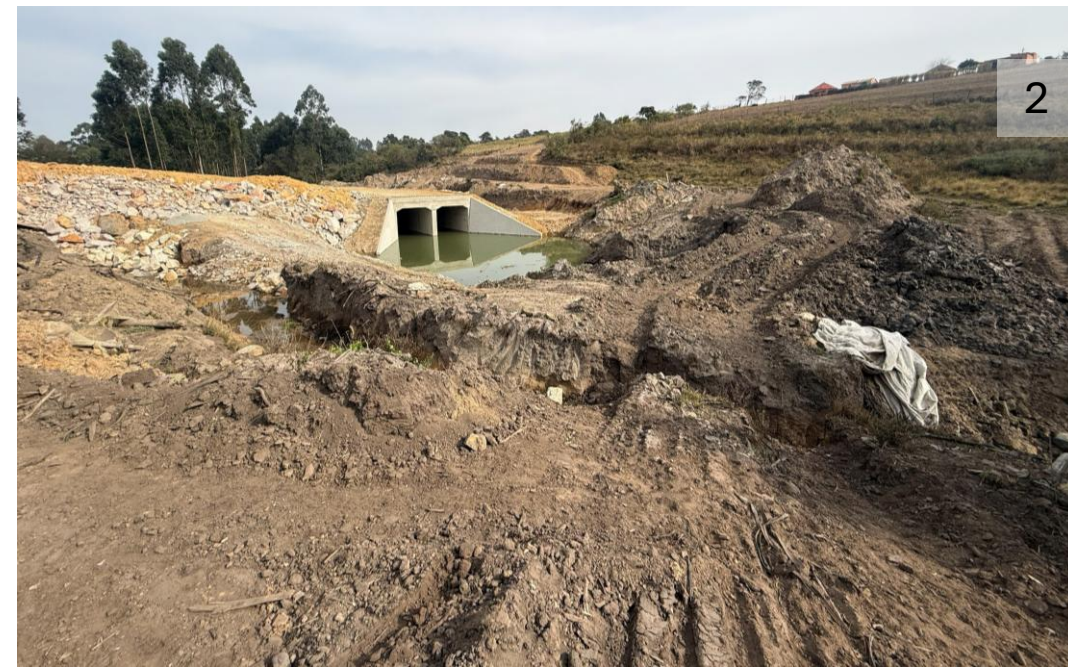
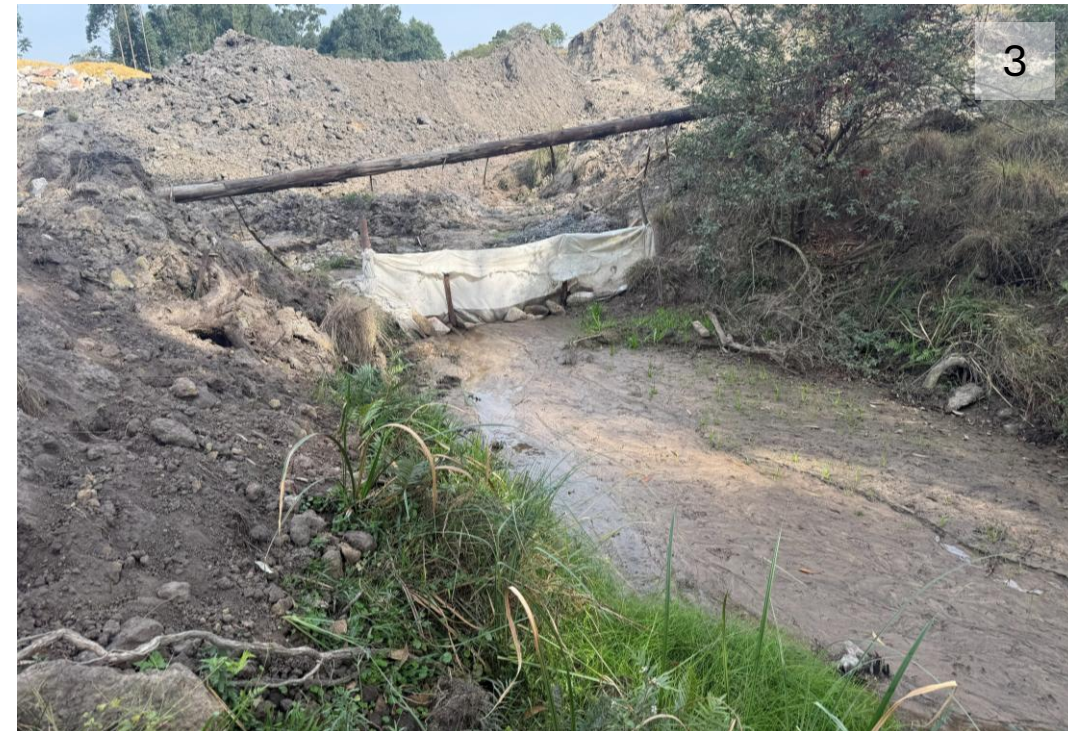
- Excessive environmental destruction – despite the need to divert flows
- Stockpiling of soil in the riparian area which has caused extensive sedimentation downstream (see silt fence with sedimentation downstream of it in photo 3)

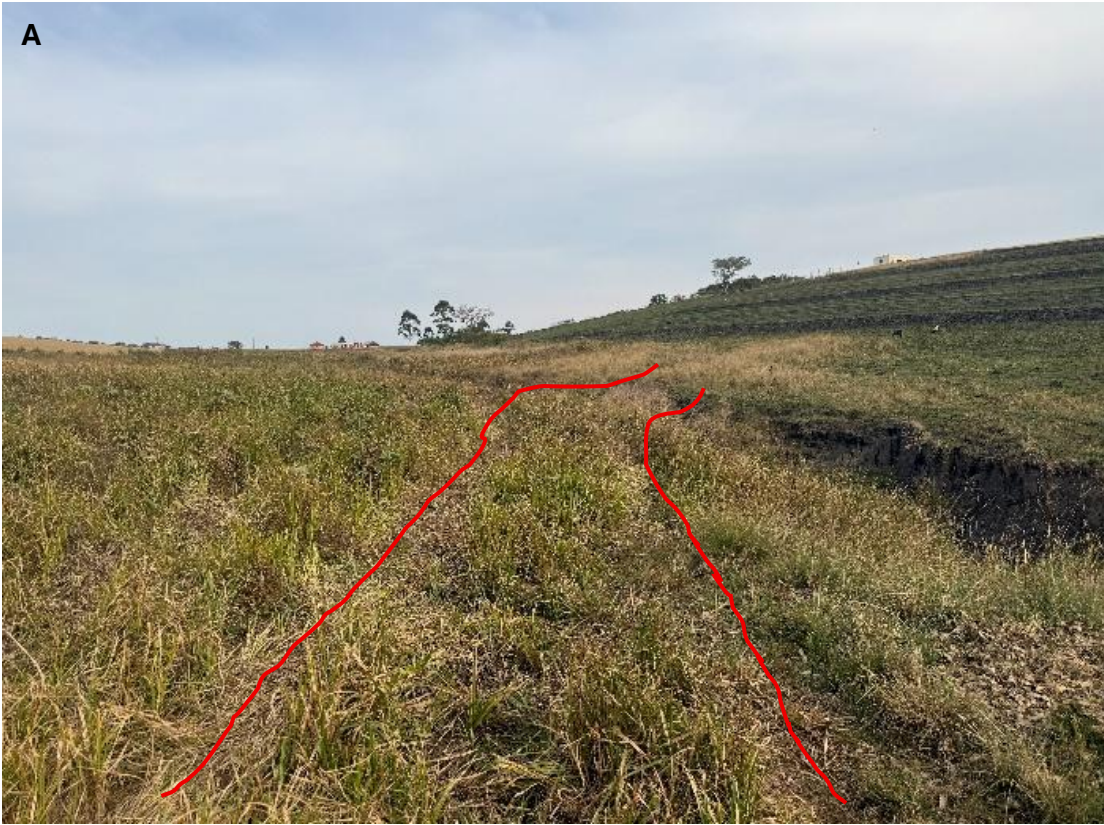
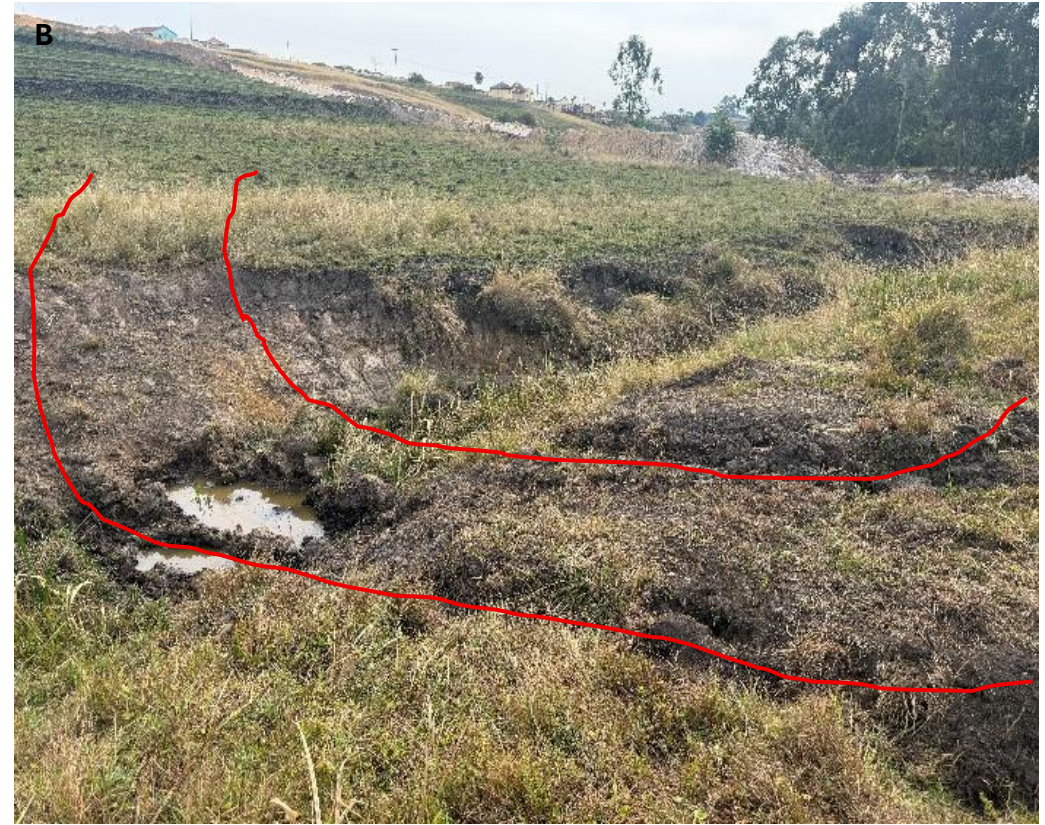
# CI-02: Excessive disturbance of wetlands and watercourses

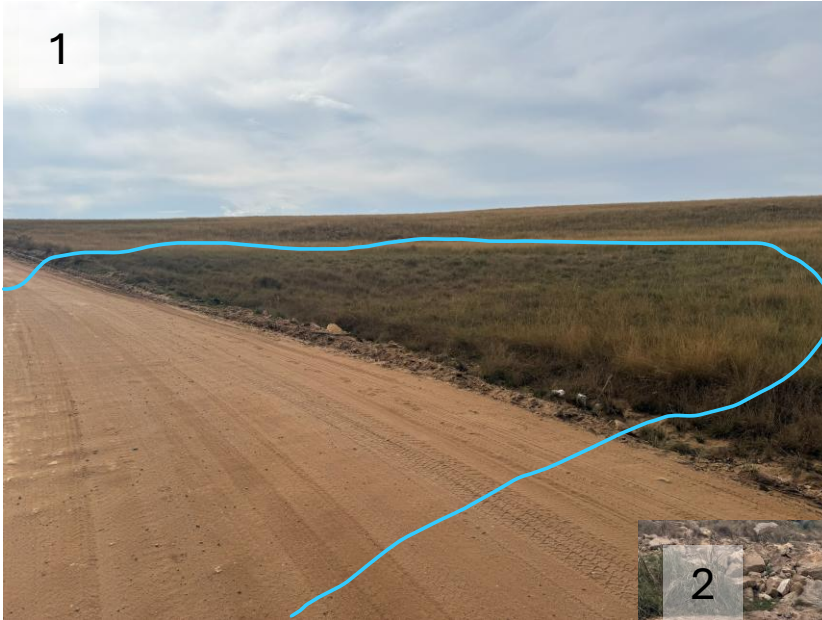
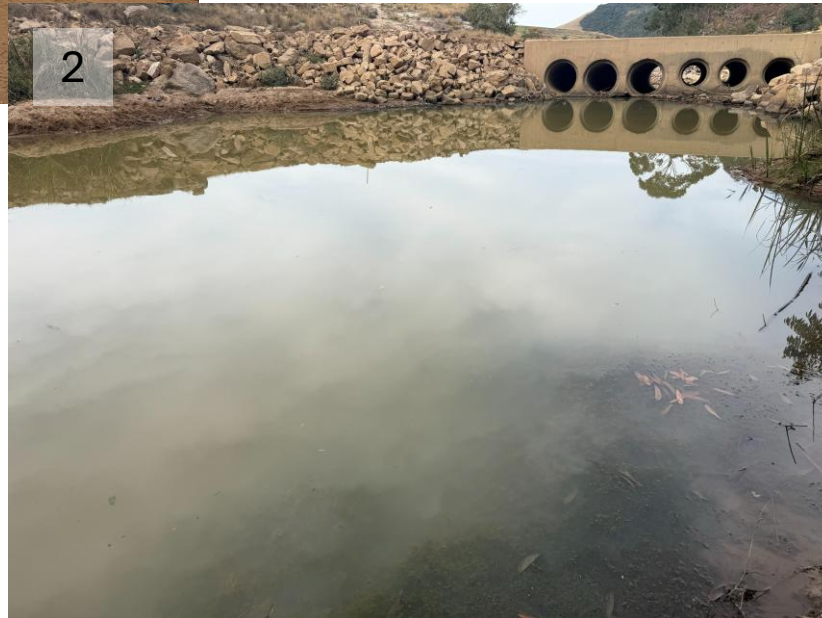
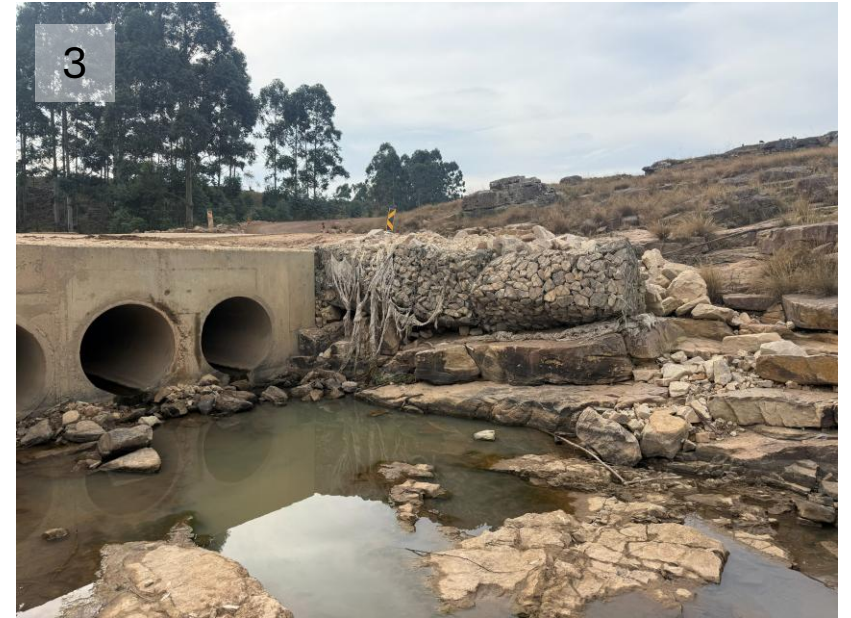
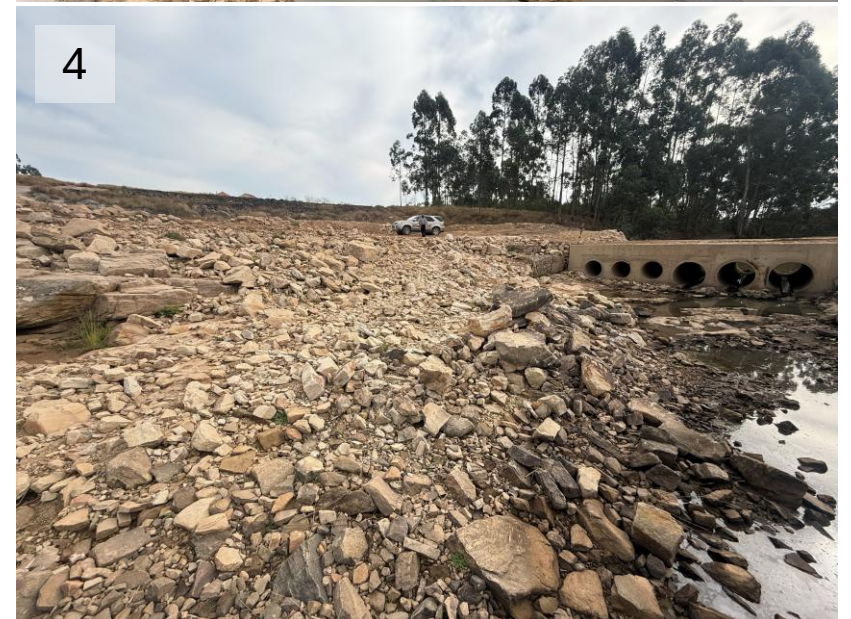
Blue line marks approximate wetland boundary

Culverts inappropriately set and cause backflow

Water appears to be sediment laden from upstream

Construction waste has been dumped within the riparian channel

Road is constructed within a wetland with no clear authorisation or plan

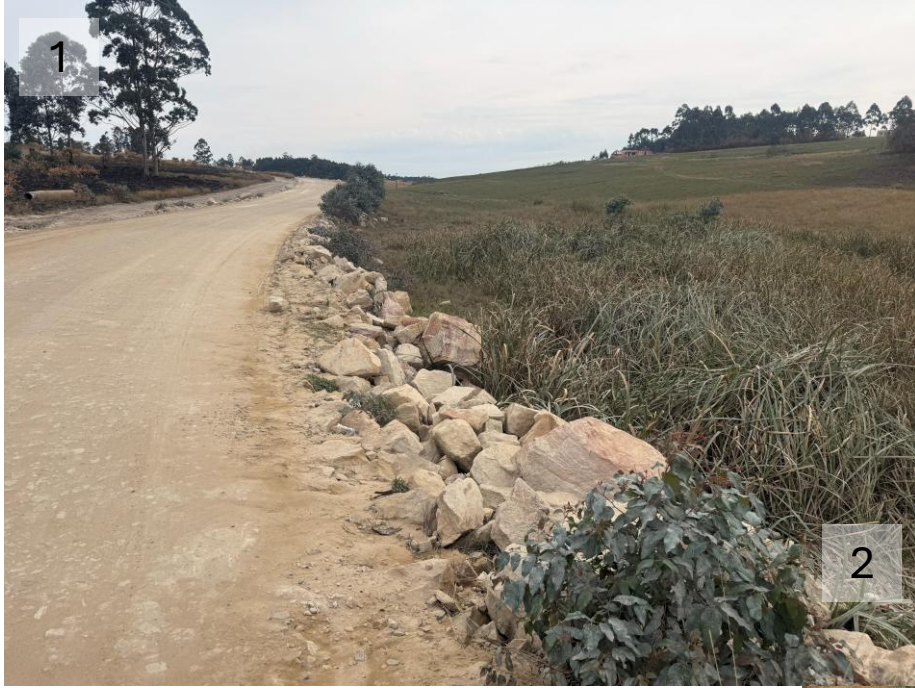
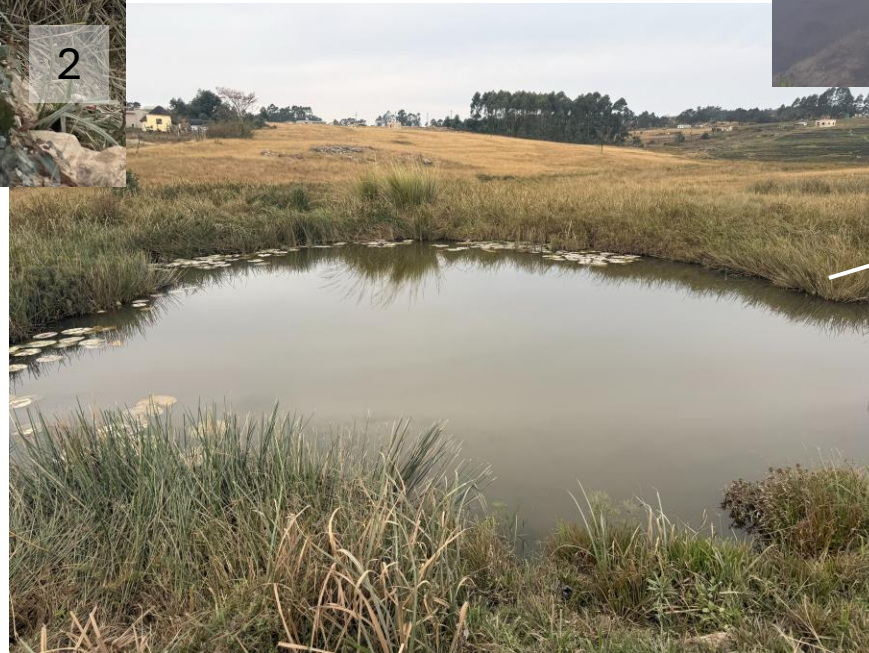
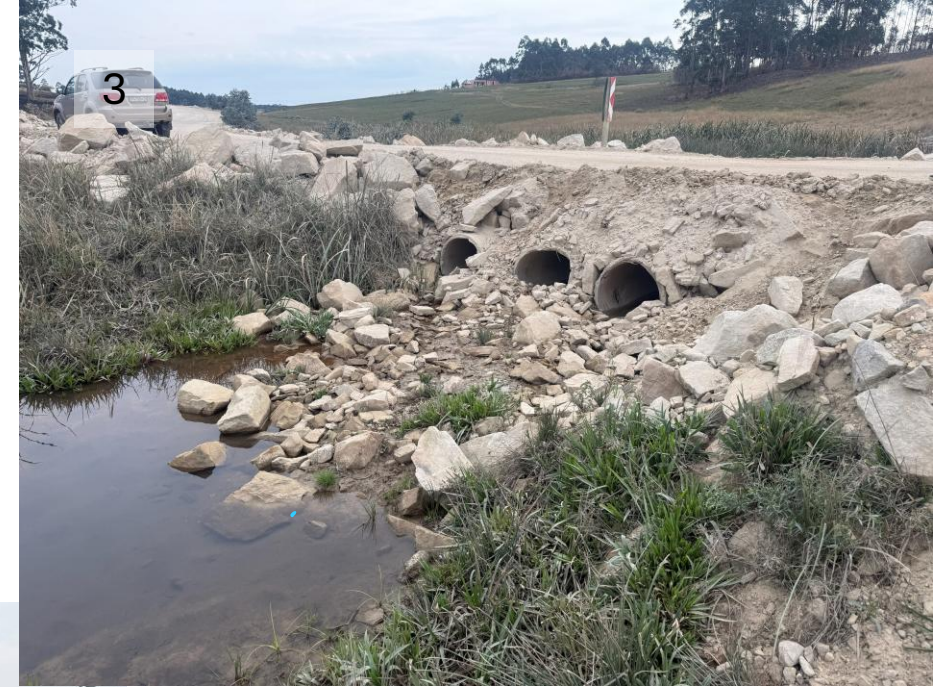
Construction waste has been dumped within the riparian channel

Road is constructed within a wetland with no clear authorisation or plan

Culverts inappropriately set and cause backflow

Water appears to be sediment laden from upstream

Local water supply pond appears to be turbid

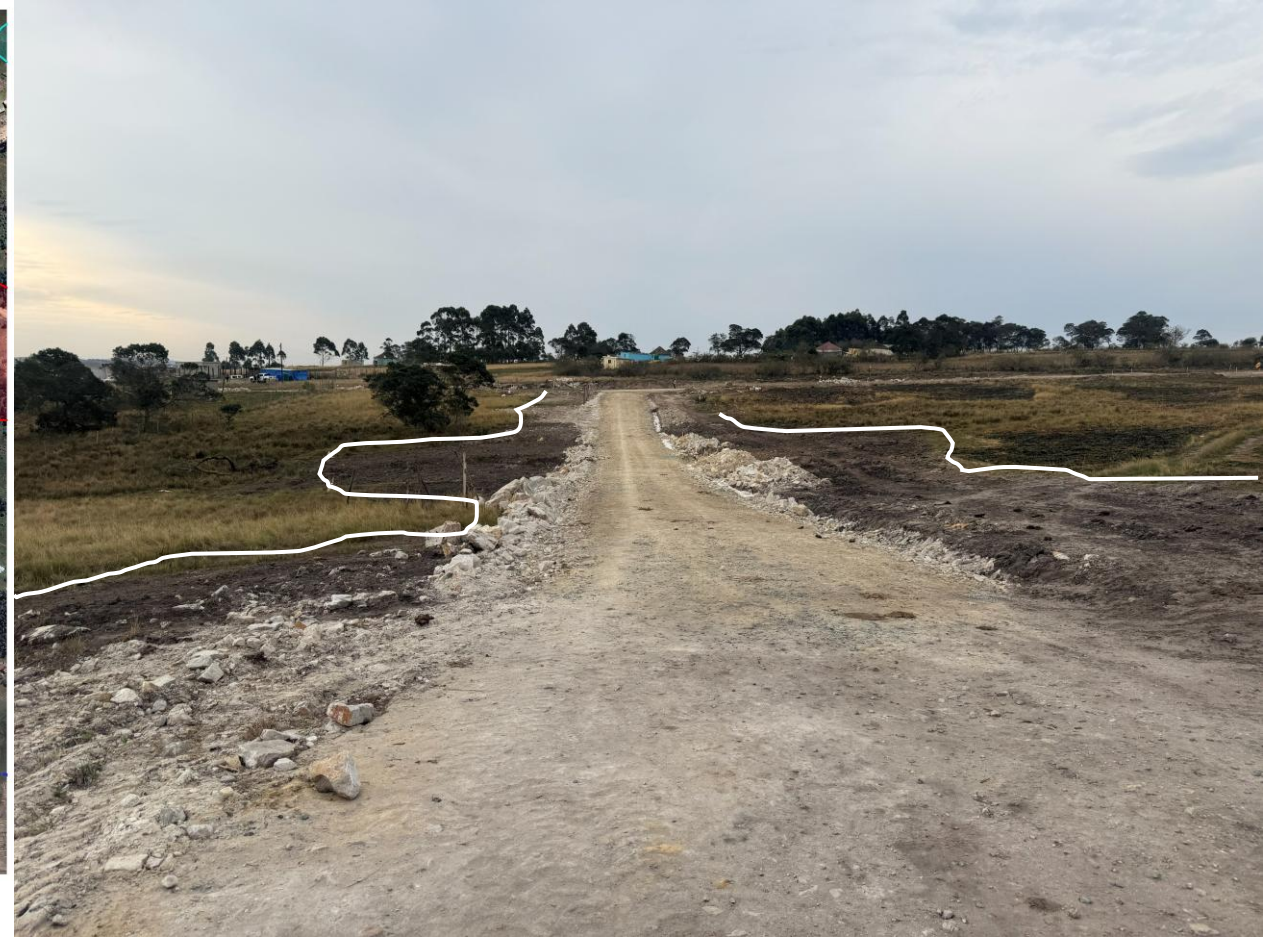
# CI-03: Potential unauthorized access road crossings – Example 3
