06 July 2026

**Field Report: Findings from a brief field assessment of selected wetlands within a 500m radius of the N2 Wild Coast Toll Highway Project between the Msikaba and Mthentu bridges.**

Compiled by Steven Ellery (Pr.Sci.Nat – Ecology, MSc - Geography)

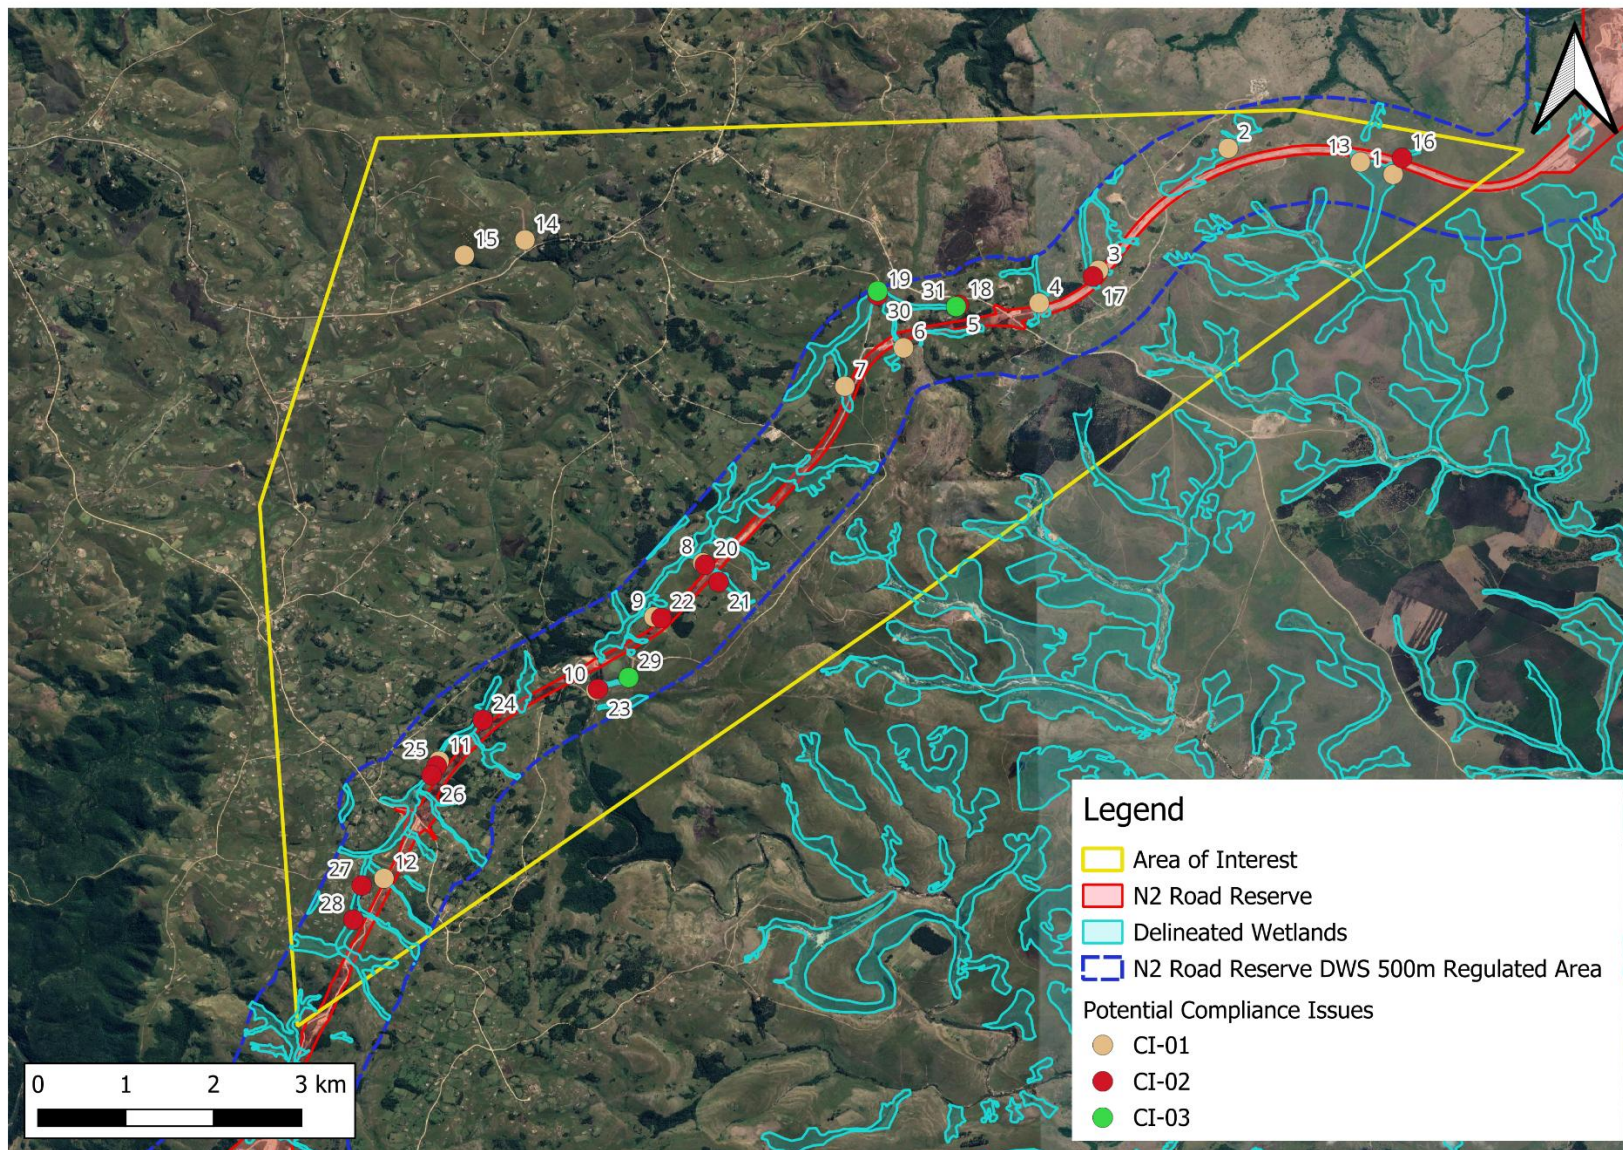
The findings from the field visit are initially categorised by their ‘type’ of impact, and then specific examples of these impacts are documented in more detail below. There are three potential compliance issues (CI’s) that were noted within the study area with a total of 15 noted instances of CI-01, 13 noted instances of CI-02 and three noted instances of CI-03 (Table 2 and Figure 2). The main claim associated with each CI is documented below:

Figure 2 Potential compliance issues in relation to the development and associated wetlands. The numbers correspond to the numbers in Table 2 above.

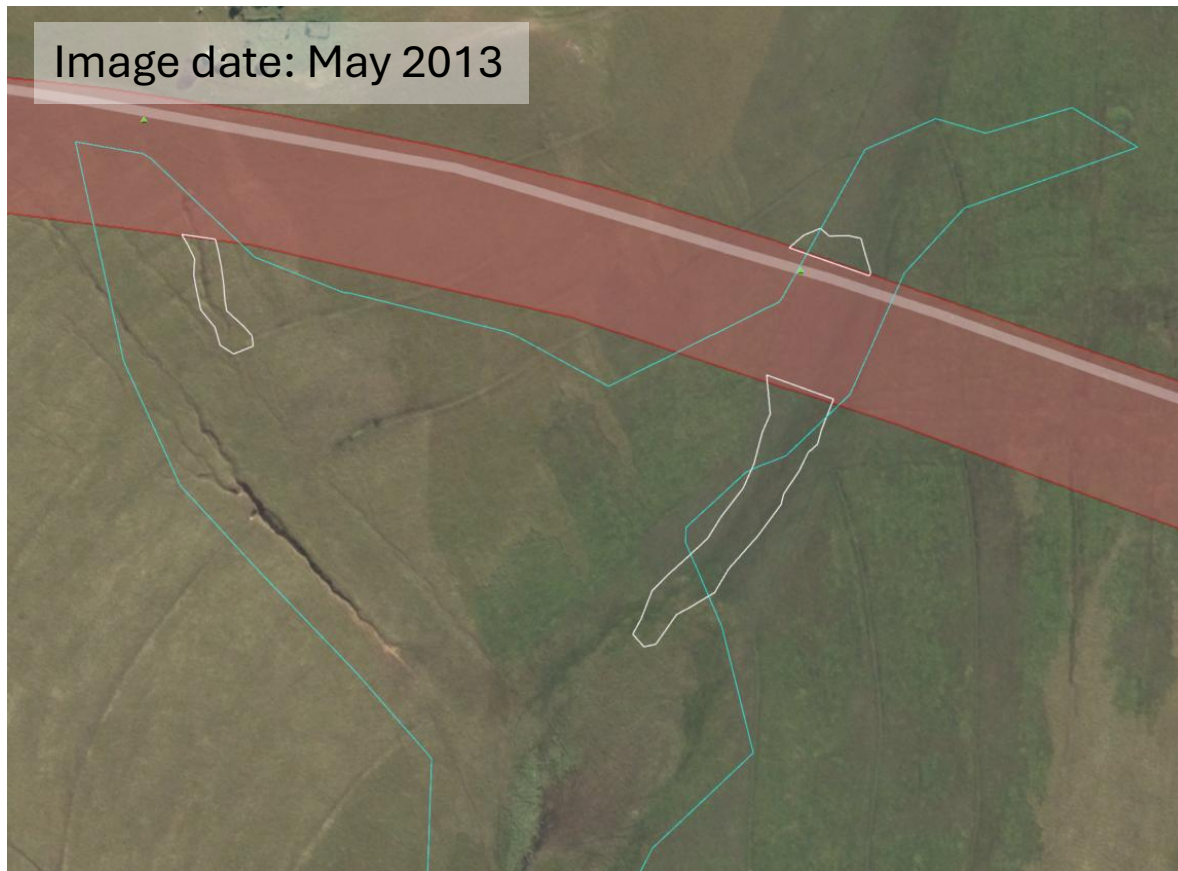
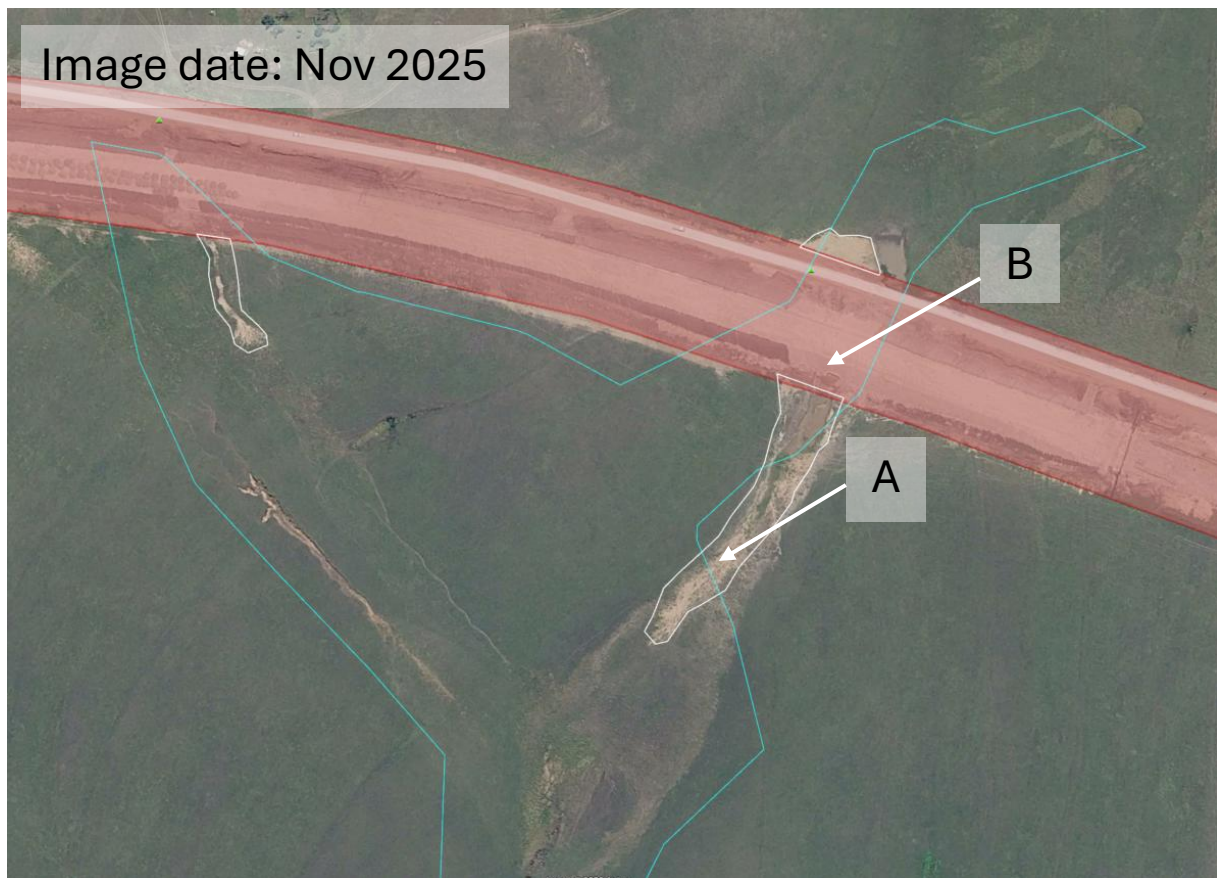
A total of 15 instances of sedimentation within watercourses were observed downstream of active construction areas associated with the N2 Wild Coast Toll Highway development. Sediment-laden runoff from exposed and disturbed construction surfaces appears to have entered multiple aquatic ecosystems as a result of inadequate stormwater management, insufficient erosion control, and poor runoff containment. An example of this is shown in Figure 3 below, illustrating CI numbers 1 and 13. The first map shows an image of the wetlands (outlined in blue) in May of 2013, prior to the development of any N2 related infrastructure (shown in the red polygon). The second map shows the same area, but in November of 2025. The white outlines indicate the approximate extent of the sediment deposition, which amounts over 5000 square meters or half a hectare.

*Figure 3 Comparison of a headwater seep and unchannelled valley bottom wetland in May 2013 and November 2025. The blue outlines illustrate the extent of the wetlands, the red polygon illustrates the N2 road reserve and the white polygons illustrate the approximate extent of the sediment deposition. The labels of A and B in the second map correspond to the location where photos A and B in Figure 4 below were captured from.*

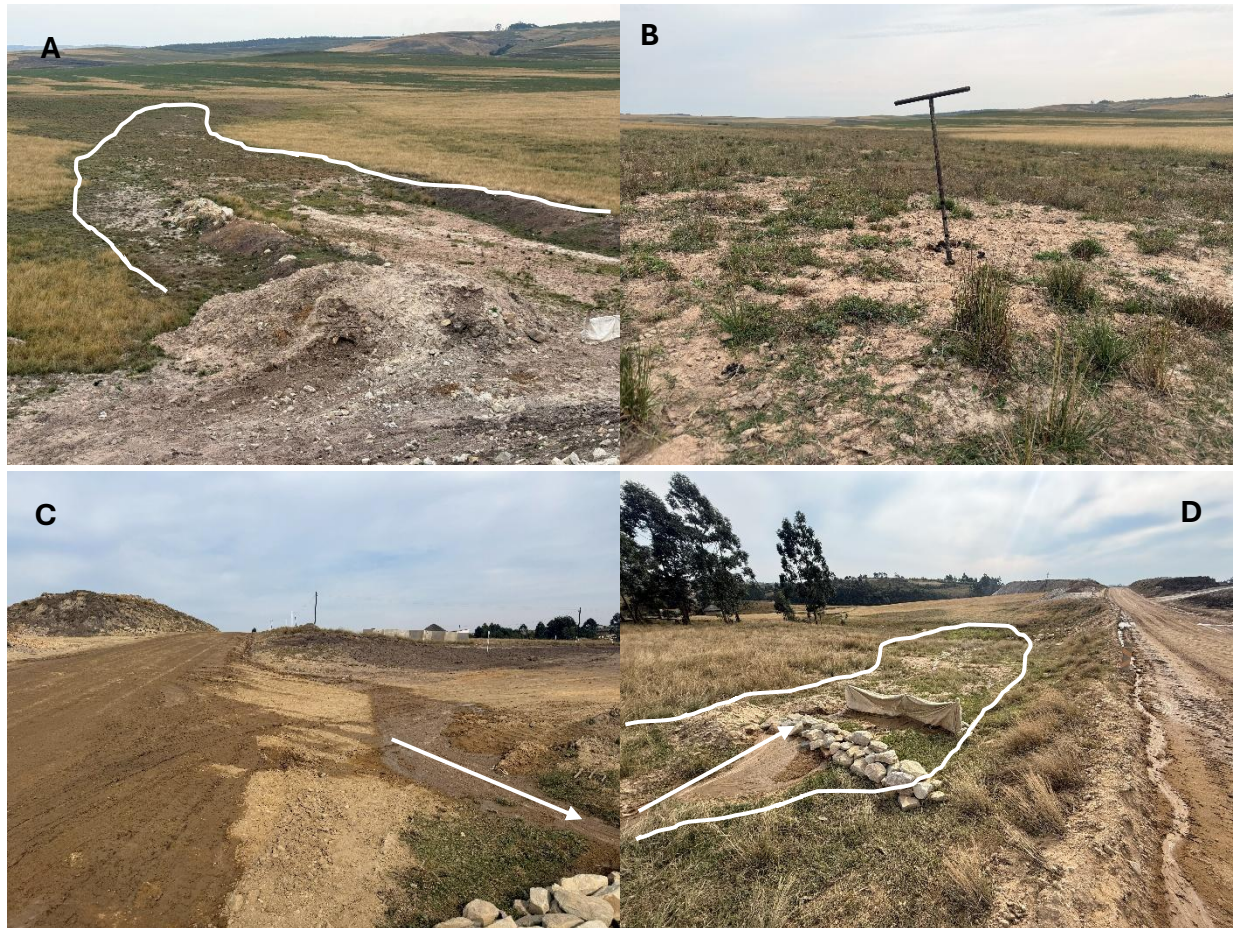
Observed impacts include significant sediment deposition within watercourses and wetlands, elevated turbidity, smothering of instream habitat (Figure 4B), and degradation of aquatic ecosystem condition. In several locations, sediment deposition appears sufficiently severe to have altered channel morphology and reduced habitat quality for aquatic biota (Figure 4).

*Figure 4 A) Extensive sediment deposition captured from the N2 road reserve (CI number 1), shown in Figure 3. B) Close up view of the large sediment plume shown in Figure 3, illustrating the extent to which wetland vegetation has been buried by the sedimentation. C) Source of CI number 12, with the white arrows indicating the path that water takes as it enters the wetland as shown in D). D) Impact of sediment within the wetland. Note some sediment control structures have been constructed, but they have been bypassed, or were constructed after the sedimentation event occurred. Find coordinates of all photographs in Appendix A.*

These observations raise serious concerns regarding compliance with Clause 26 of the project EMP, which specifically addresses erosion and sediment control during construction. Clause 26 requires the Contractor to protect erosion-prone areas through the installation of temporary and permanent drainage works as soon as possible and to implement measures necessary to prevent surface water from concentrating into streams or scouring slopes, banks, and other vulnerable areas. The clause further requires the development of a dedicated Method Statement addressing erosion control prior to the commencement of bulk earthworks. In addition, erosion channels developing during construction are required to be backfilled and restored, exposed areas must be stabilised, and movement over stabilised areas must be restricted and controlled.

The observed sedimentation indicates that one or more of these requirements were either inadequately implemented, not maintained, or absent altogether.

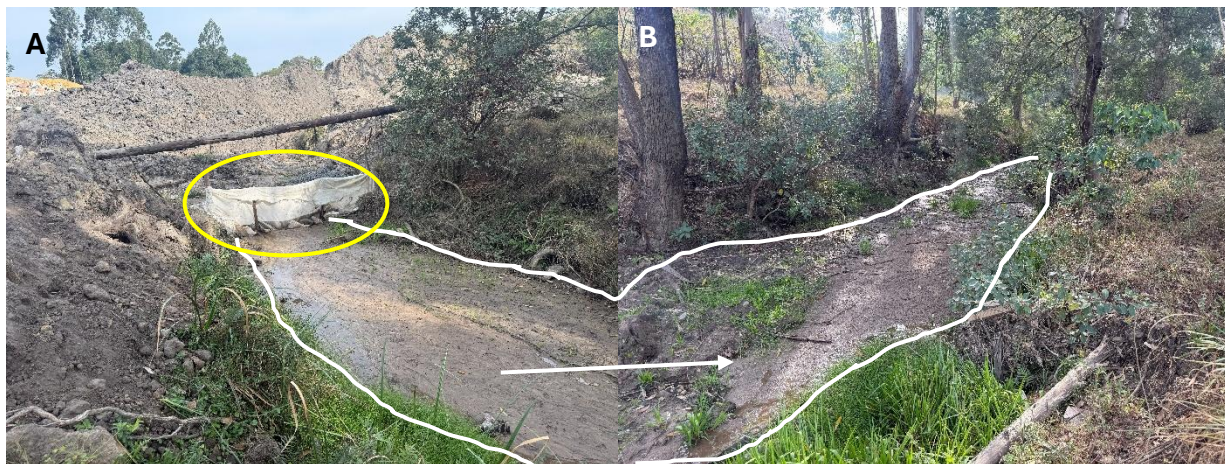
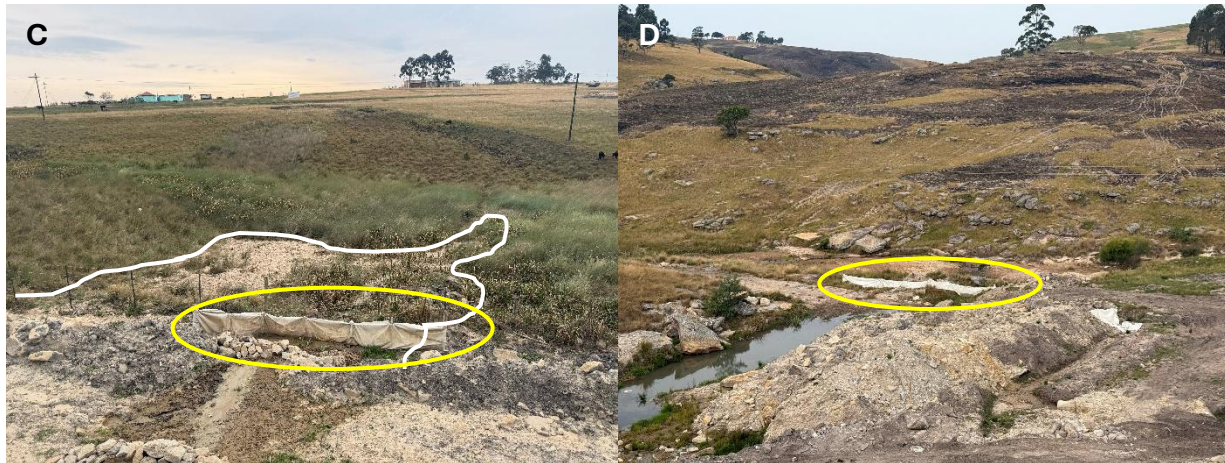
It is acknowledged that some attempts to manage sediment have been undertaken by the contractors on site. However, in many cases, these sediment control interventions appear to have been implemented only after sedimentation events had already occurred, indicating a reactive rather than preventative approach to sediment management (Figure 5A and B). Furthermore, several of the installed controls appear to be inadequately keyed into the surrounding ground or insufficiently designed for site-specific conditions, reducing their effectiveness during high-flow events (Figure 5C and D). This is of particular concern, as the greatest risk of sediment mobilisation and downstream transport occurs during intense rainfall and peak flow conditions, when sediment control measures are required to perform most effectively.

*Figure 5 A) A sediment control structure that is completely ineffective or was installed after the sedimentation event occurred as indicated by the white lines. B) Is the downstream portion of the river channel that has been buried with sediment (CI number 11). C) A sediment control structure that has been completely bypassed by sediment washed from the road works and is now sitting within a wetland (CI number 2). D) A sediment control structure that has been completely bypassed by sediment washed from the road works and is now sitting within a river channel (CI number 6). Find coordinates of all photographs in Appendix A.*

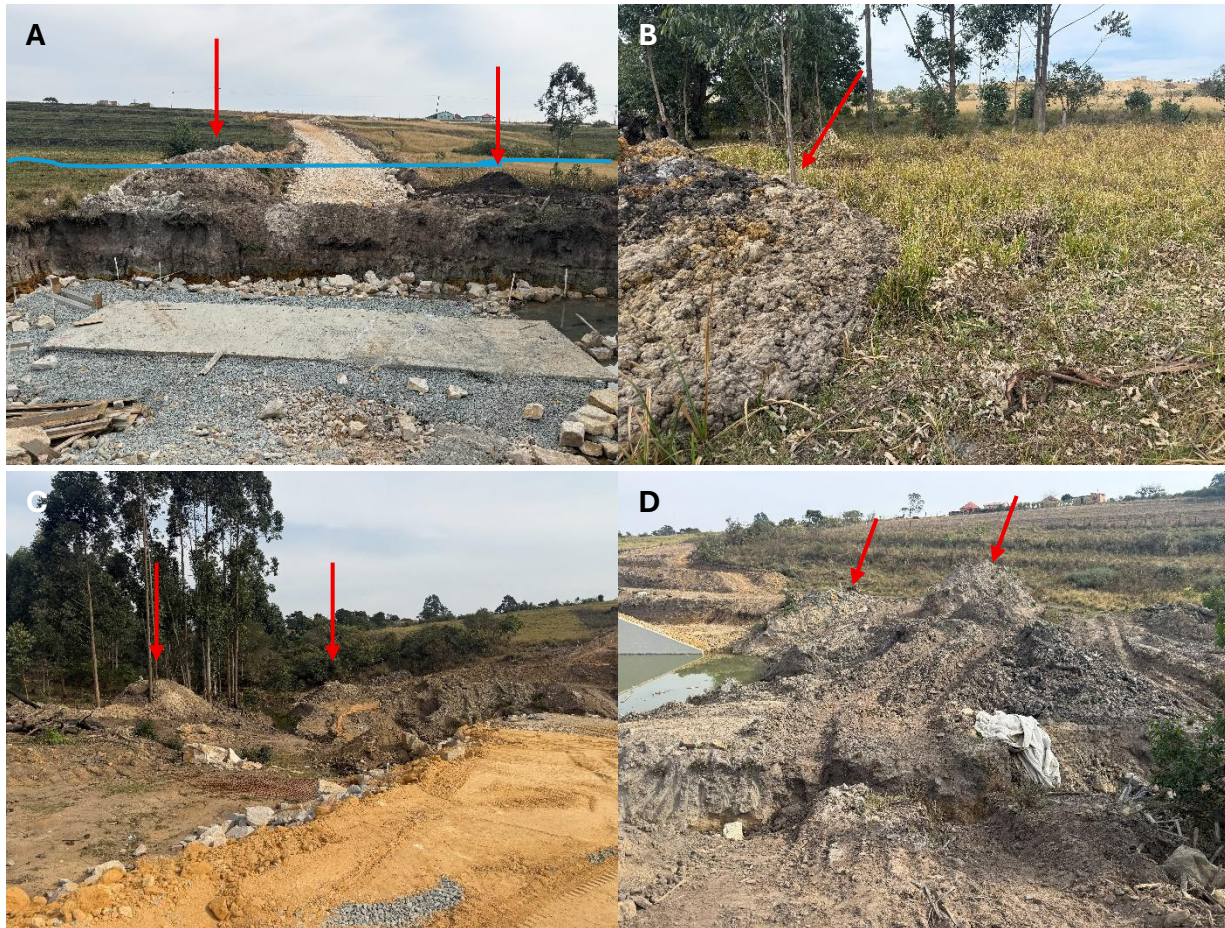
A key concern relates to the stockpiling of excavated spoil material and imported construction material within watercourses and directly adjacent to wetland and riparian areas. In multiple locations, stockpiled material was observed within sensitive aquatic environments without evidence of adequate erosion protection or containment measures (Figure 6). This is of particular concern given the increased risk of sediment mobilisation during rainfall events and the resulting downstream degradation of aquatic ecosystems.

Figure 6 A) An access road crossing a channelled valley-bottom wetland. The blue line indicates the approximate boundary of the wetland and the red arrows indicate stockpiles located within the wetlands (CI number 28). B) Also shows CI number 28, although indicating another stockpile dumped within sensitive wetland vegetation such as *Dissotis canescens*, *Phycnostachys* sp, *Cyperus latifolius* and other species. C) An access road crossing a riparian habitat with extensive stockpiling of material within the riparian corridor with little to no sediment control measures (CI number 25). D) Downstream of CI number 25 is CI number 26 as depicted in this photograph. Find coordinates of all photographs in Appendix A.

The observed stockpiling appears inconsistent with multiple provisions of the project Environmental Management Programme (EMP). Clause 20 explicitly states that no construction camps, dumping, or stockpiling of construction material shall be allowed in or close to wetlands and other watercourses, while Clause 8 further states that no materials shall be stockpiled in any wetland areas. Clause 5 additionally requires all temporary stockpile areas to be approved and demarcated, and stipulates that stockpiles must be constructed and maintained to avoid erosion and contamination of the surrounding environment, including preventing material from spilling into rivers and drainage lines.

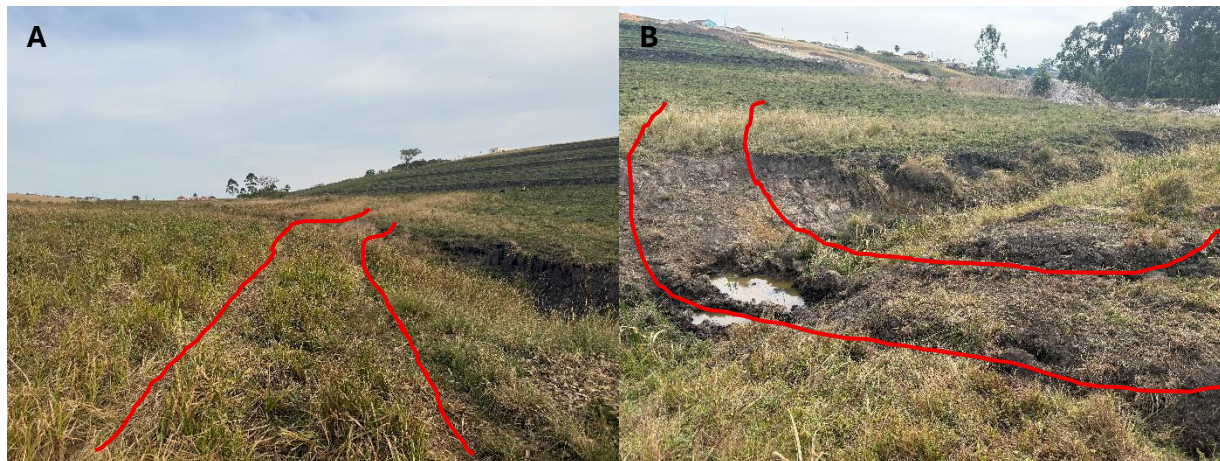
Further concerns arise from evidence of heavy construction vehicles, including tracked excavators, moving through intact wetland areas beyond the immediate crossing footprint. This activity has caused substantial physical disturbance, including vegetation destruction,

soil compaction, rut formation, and surface deformation (Figure 7). Such disturbance has the potential to impair wetland hydrological functioning by reducing infiltration, altering surface flow pathways, increasing runoff concentration, and reducing the natural buffering capacity of wetlands.

*Figure 7 A) Red lines indicate the path taken by a large tracked vehicle (likely an excavator) through an intact portion of wetland to cross the channel pictured in B) (CI number 28). B) Red lines indicate the path taken by the large tracked vehicle across the channel. Not extensive disturbance and vegetation removal as a result of the excavator having to turn to cross the channel at right angles. Find coordinates of all photographs in Appendix A.*

This disturbance appears inconsistent with Clause 20 of the EMP, which explicitly states that no activities shall take place outside demarcated construction areas and that disturbance to environmentally sensitive areas must be avoided. The clause further requires that the construction servitude through wetland areas be kept to a minimum. Based on site observations, the extent of disturbance in certain areas appears to exceed the minimum footprint reasonably required for crossing construction.

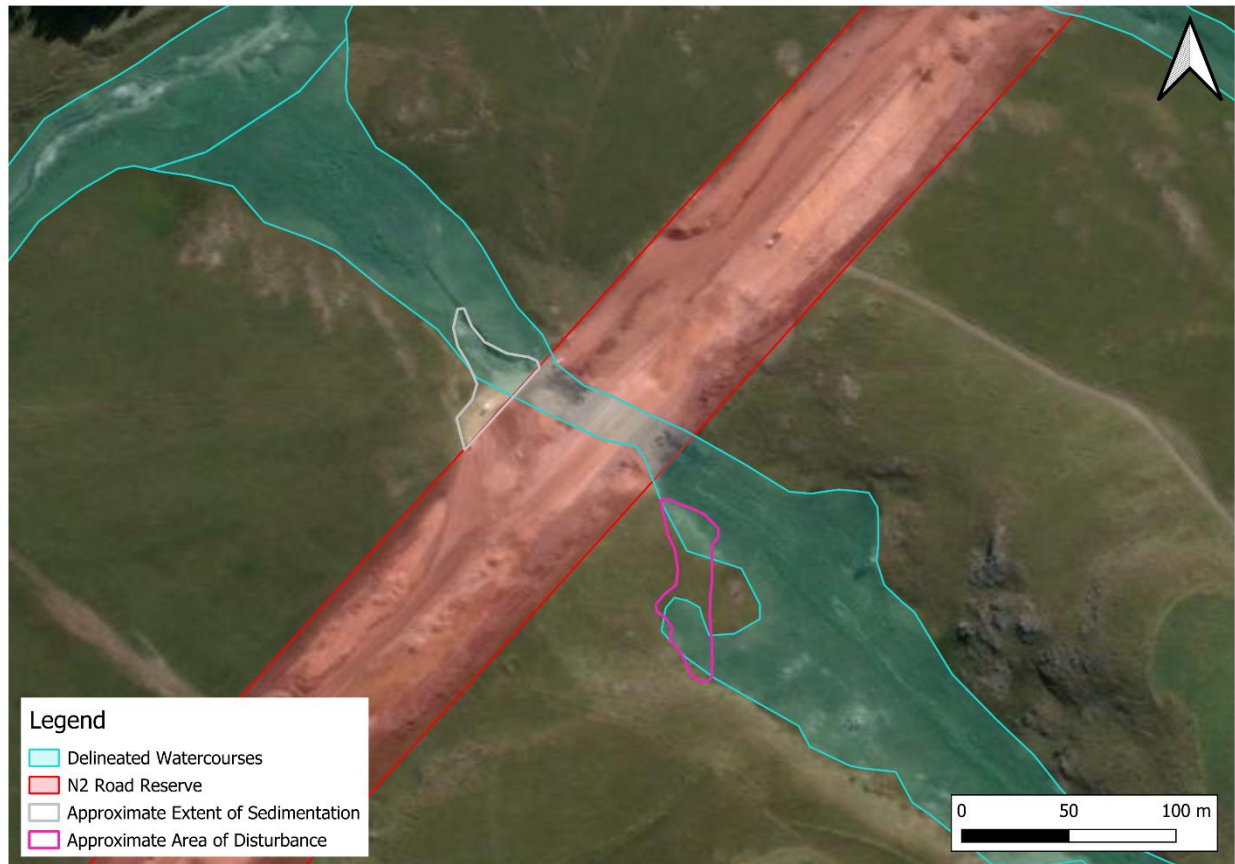
A further concern relates to the unnecessary clearing of natural vegetation within sensitive aquatic habitat. In one observed instance, a large area of vegetation was cleared on a steep slope within a seep wetland for no apparent or clear construction-related purpose (Figure 8). The extent and location of this clearing raise significant concerns regarding whether disturbance was appropriately minimised and restricted to the footprint strictly required for construction activities. The location of the clearing within a steep seep wetland is of

*Figure 8 CI number 21 is indicated by the pink polygon and CI number 8 is indicated by the grey polygon. The area within the pink polygon has been completely cleared, with no further work done on it.*

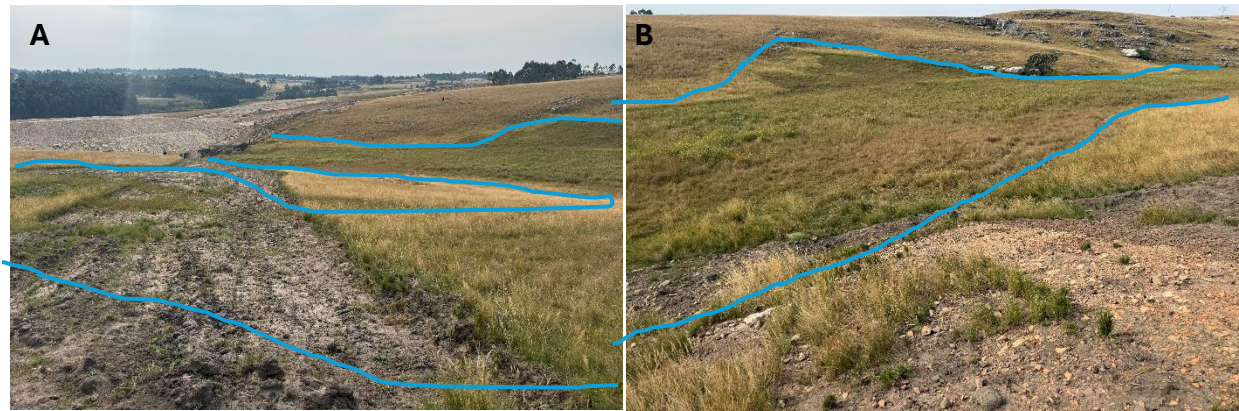
particular concern due to the ecological sensitivity of these systems and their susceptibility to hydrological disturbance, erosion, and channelization (Figure 9A). Vegetation removal in such areas may reduce slope stability, increase runoff concentration, accelerate sediment mobilisation, and impair the wetland's natural hydrological functioning (Figure 9B). Where such clearing was not strictly necessary or appropriately authorised, it may constitute further evidence that the construction footprint has not been adequately minimised in accordance with EMP and Aquatic EMPr requirements.

*Figure 9 Photographic evidence of CI number 21 as shown in Figure 8. A) Shows the cleared area from the south looking towards the valley bottom wetland, with the approximate wetland extent shown by the blue lines. B) The valley bottom wetland shown by the blue lines with some sediment having washed from the cleared area into the valley bottom. Find coordinates of all photographs in Appendix A.*

This clearing appears inconsistent with several provisions of the project Environmental Management Programme (EMP). Clause 2 (Design Phase: Sensitive Areas) requires that vegetation clearing be minimised and restricted to the area required for road construction purposes only. Clause 10 (Design Phase: Access/Haul Roads) further states that, where access roads are required outside the road reserve, vegetation clearing may only occur following written approval from the Engineer, with input from the Project Environmental Manager (PEM) and/or Environmental Control Officer (ECO). Clause 3 (Construction Phase: Site and Construction Camp Clearing) additionally requires that, prior to clearing natural vegetation, the Contractor submit a plan of action and Method Statements to the Engineer, PEM, and ECO for approval.

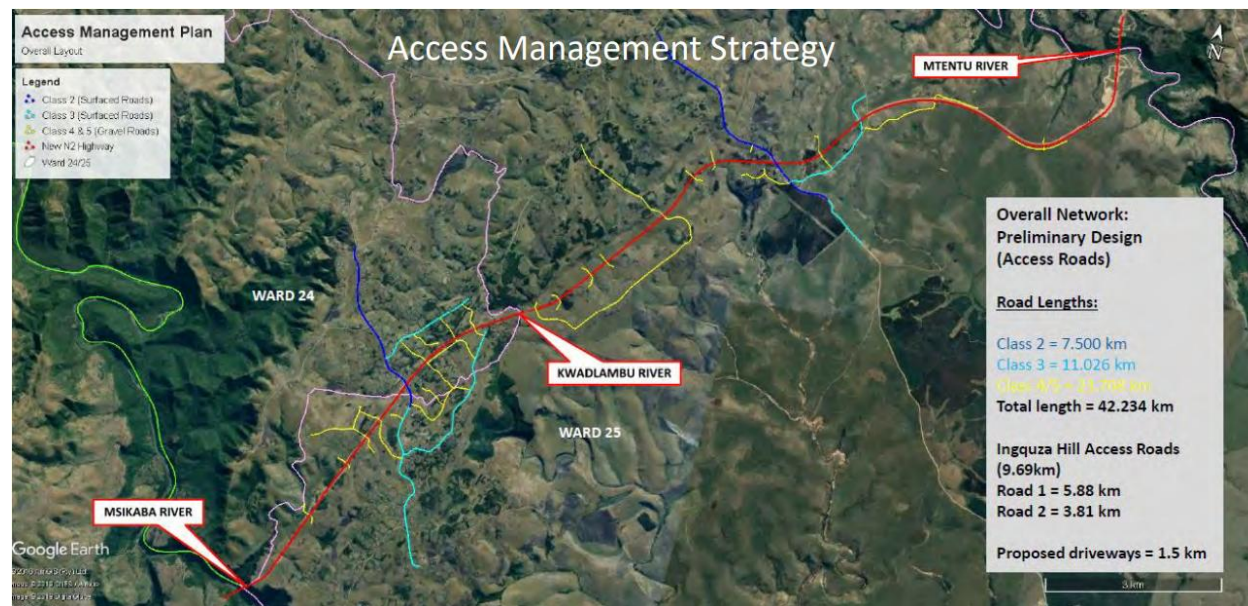
In addition, a map of planned access roads for the Greenfields section, obtained from an Environmental Management Committee (EMC) meeting presentation dated February 2025, was reviewed to provide additional context regarding planned construction access routes (Figure 10). While this map provides useful insight into project planning, it is acknowledged that inclusion of an access road within the EMC presentation does not constitute regulatory authorisation and should therefore not be interpreted as evidence of lawful approval.

Figure 10 Map obtained from the Environmental Management Committee meeting from February 2025 (Accessible at: <https://cdn.sanity.io/files/b0ecix6u/production/190ae19440835959b4195df247e4d717b6722e39.pdf>), showing the planned access roads through the Greenfields section. The roads largely correspond to those observed on the ground, barring two access roads through watercourses as elucidated on in Figure 11 and 12.

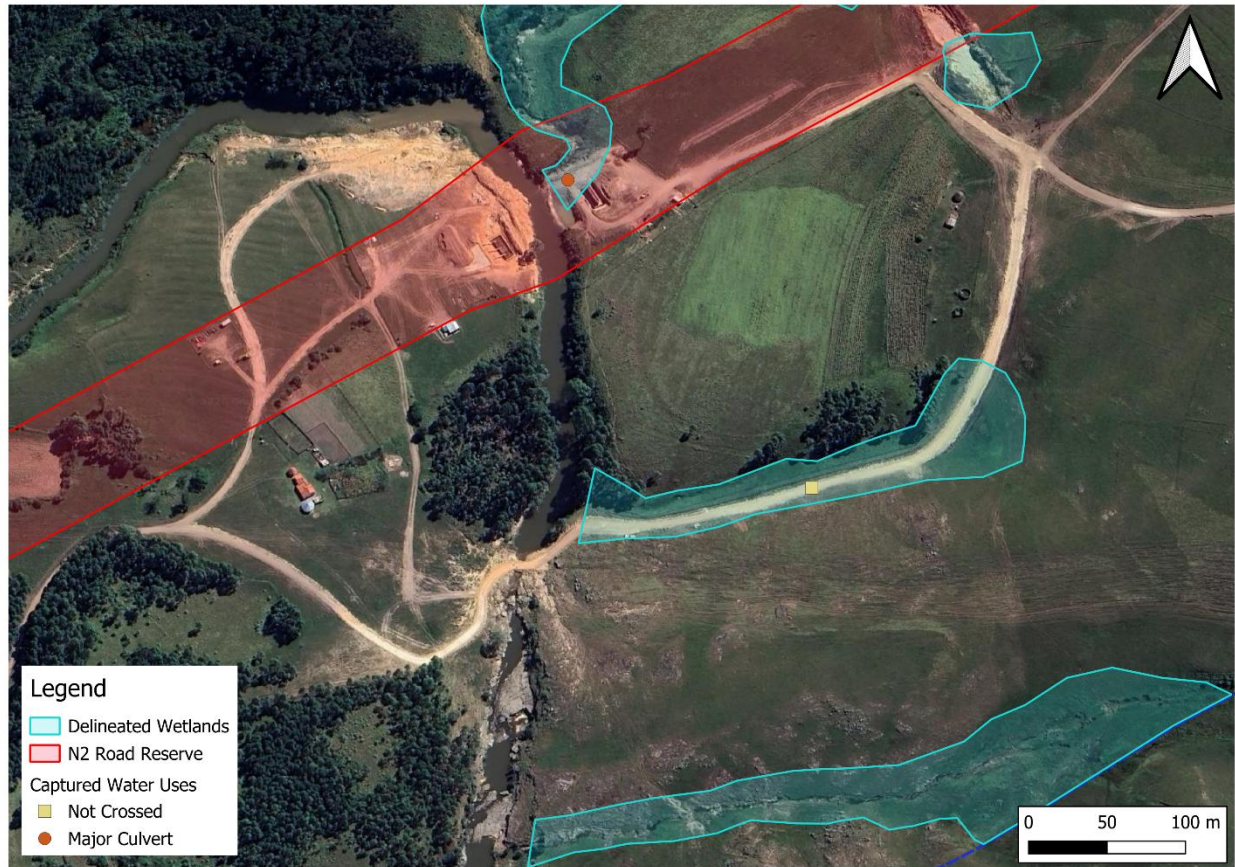
The spatial assessment identified several smaller access roads that appear to cross watercourses but do not correspond with the currently available authorised crossing locations. Of particular concern, two access roads crossing watercourses were identified that are not reflected in either the publicly available authorisation documents or the February 2025 EMC access road map, suggesting that these crossings may represent previously unidentified or unplanned access routes. As shown in Figure 11, an access/haulage road has been constructed through a small seep wetland and a larger river. Cross referencing this location with the coordinates contained within the General Authorisations documents, the authorisation states that the wetland is 'Not Crossed'. Furthermore, this access road is not shown on the access road map in Figure 10, meaning that, as far as the public knows, there is no authorisation for this road through these watercourses. It is noted that this road did not exist in May of 2022, but it appears in the Google Earth image from March of 2024.

*Figure 11 The captured water uses overlaid with the delineated wetlands. Note the general authorisation for the wetland in the centre of the map states that it is 'Not Crossed'. However, as seen in the map, there is a large road directly through the wetland (CI number 29).*

Given the potentially serious implications of unauthorised or unnecessary watercourse crossings, further verification is recommended to confirm whether additional approvals, amendments, or site-specific authorisations exist for the identified access roads, and to assess whether all constructed or planned access routes are demonstrably necessary for construction purposes.

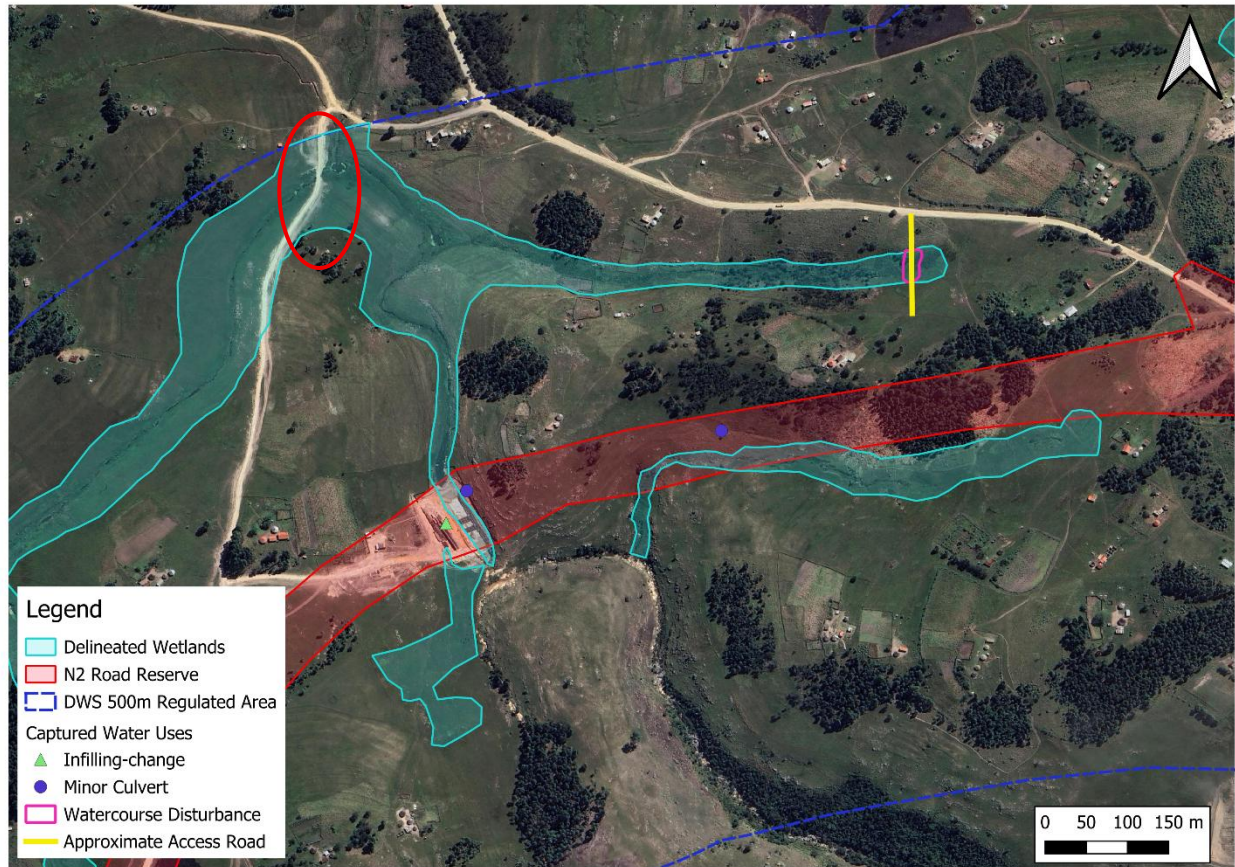
Figure 12 highlights a second instance where there is no known authorisation for the road that has been constructed, and the road is similarly not reflected on the access road map shown in Figure 10. It appears that this road has been constructed as a shortcut, so that vehicles can drive directly south to the road reserve as opposed to driving east before the existing road joins with the road reserve. It is noted that this road did not exist in its current extent in May of 2022, but it appears in the Google Earth image from March of 2024. It is noted that a small track does appear in the Google Earth image in May of 2022.

Figure 12 The captured water uses overlaid with the delineated wetlands. Note that there is no authorisation at the location where the road crosses this wetland highlighted by the red oval (CI number 30). An additional access road and associated disturbance is shown by the yellow line and pink polygon (CI numbers 5, 18 and 31).

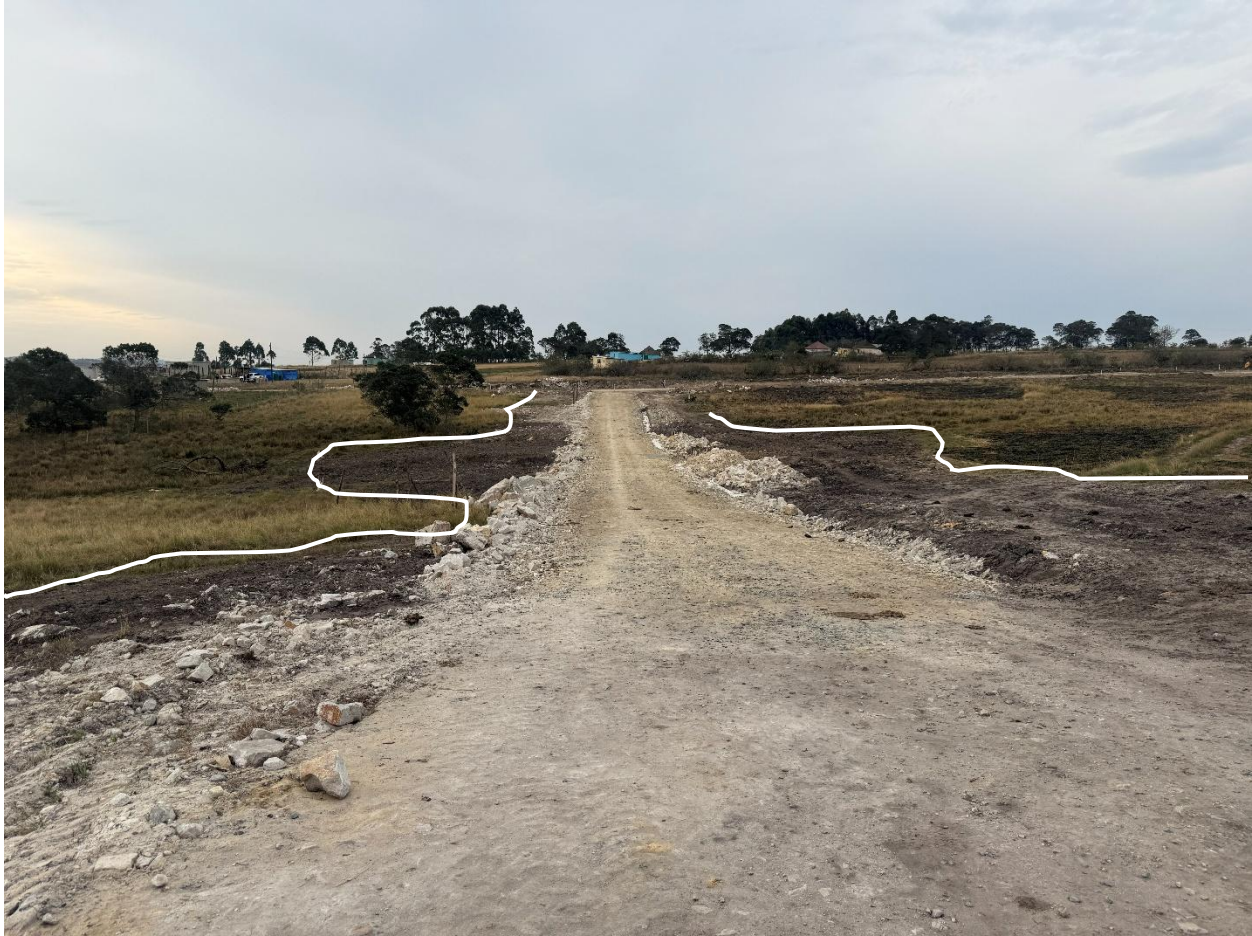
Furthermore, several access roads shown on the EMC planning map appear to have unclear construction-related objectives and, in certain instances, may represent unnecessary disturbance, particularly where they involve additional crossings through wetlands or watercourses (as represented by the yellow line and pink polygon in Figure 12 and shown in Figure 13). The road crossing appears to lead to a household and has not yet been linked in any clear way to the construction site. While this road is shown on the EMC map in Figure 10, the questions regarding 1) the necessity of the road and 2) why the road was placed through a wetland in the first place are raised. If this road had been planned appropriately, and had been appropriately checked by the resident engineer and environmental compliance officer, simply moving the road 30m upslope would have been sufficient to minimise damage to the wetland. This raises concerns not only regarding possible authorisation gaps, but also whether the project has adequately minimised the number and extent of access routes through sensitive aquatic ecosystems.

*Figure 13 Road crossing through the head of a wetland. The road crossing appears to lead to a household and has no clear link to the N2 Road Construction site. Find coordinates of all photographs in Appendix A.*
